ADDENDUM NUMBER ONE

RFP 12-1989 Chehalem Forest Stand Management

MEMORANDUM

Date: July 26, 2010
To: Kate Holleran, METRO
From: Tim Blackwood, PE, CEG
Regarding: Preliminary Geotechnical Evaluation
Chehalem Ridge Property
Project No. 1344-002-00

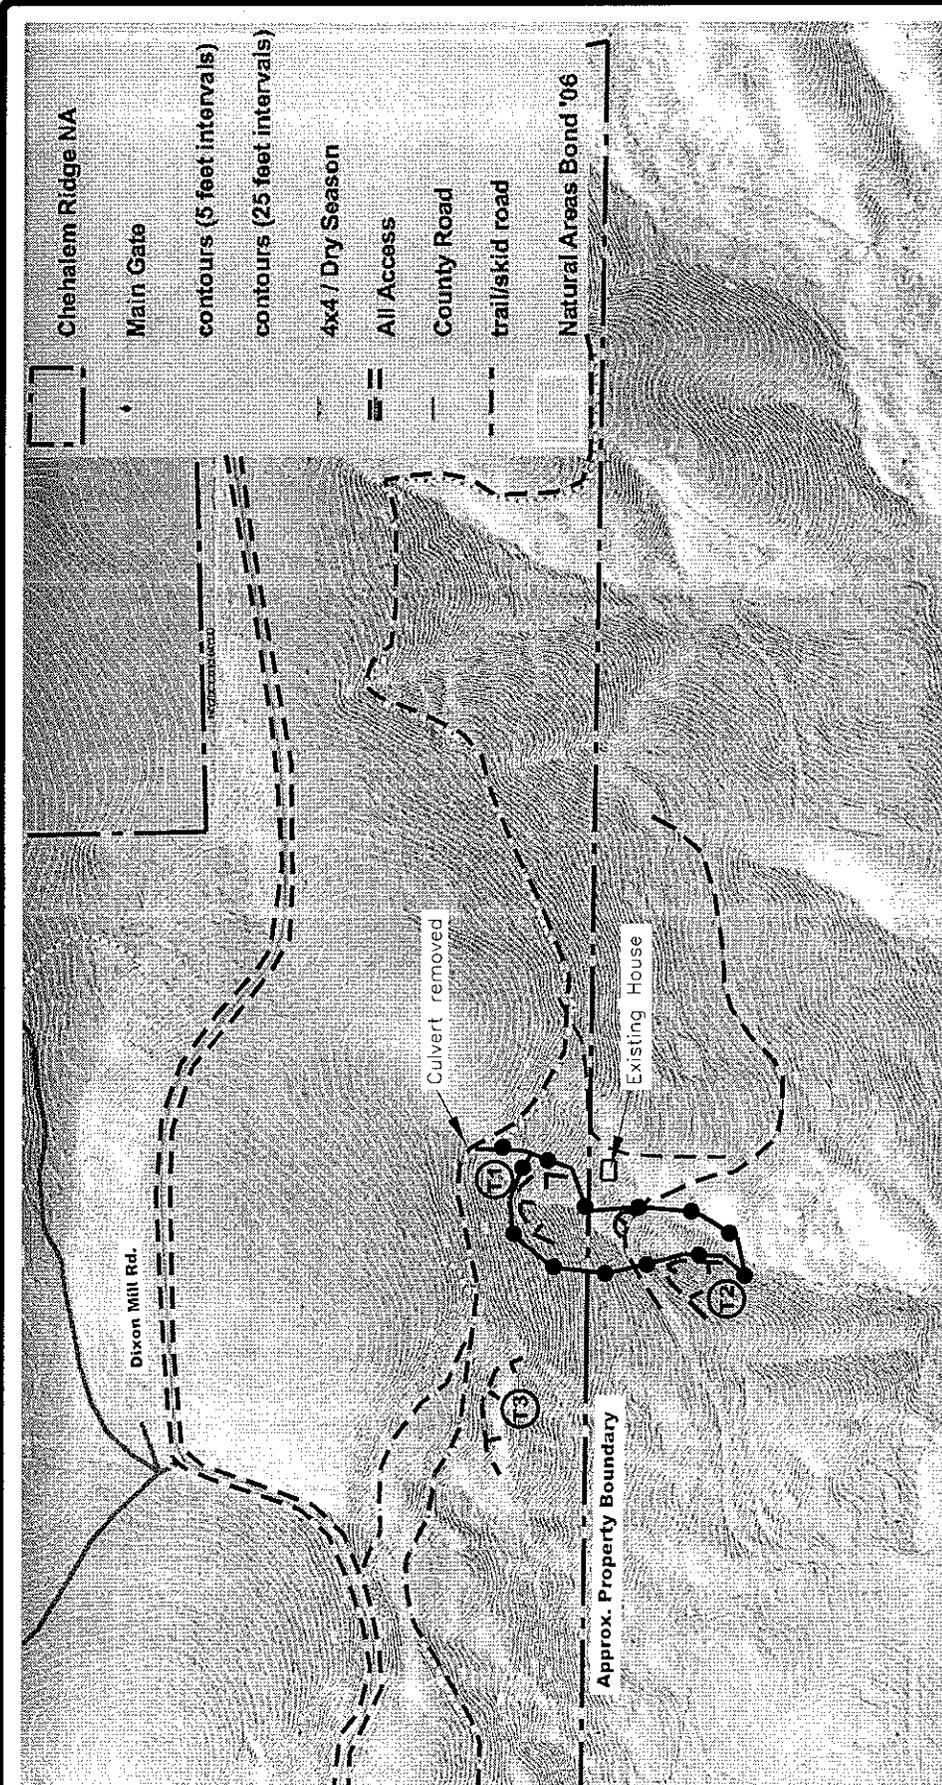
DWG NAME:	Site and Traverse Map
DESCRIPTION:	Chehalis Ridge Washington County, Oregon
JOB NO.:	1344-002-00 DATE: 7/15/10
FILE NAME:	134400200F2 Siteplan.dwg
	FIGURE 2

We conducted a visit to the site on June 11th, 2010. Our visit included a visual reconnaissance of the affected area and areas below the site on the adjacent property to the south. Our observations are documented below, with specific locations of significant findings shown on Figure 2.

- The area of the subject ground movement is a recent landslide which appears to be mostly translational. The average slope gradient in the landslide area is about 40 to 50 percent. The head of the slide occurs beneath the road and approximately centered on a small swale/ephemeral stream and coincident with a culvert outfall from the roadway. The head of the slide is defined by about a 5 feet high vertical scarp, as shown at Station 1, on Figure 2. The scarp exposes silty soil, is slightly weathered but is not yet revegetated, consistent with a landslide occurrence of within about the last 10 to 15 years. The scarp continues downslope on the west side where its height decreases to about 2 feet, transitioning to the toe of the landslide. The toe is comprised of a deposit of soil and vegetation that rode over in-place ground downslope of it. The toe did not liquefy and continue as a debris flow, but deposited on an approximately 50 percent slope. Trees within the landslide area included straight conifer as well as some tilted and bowed conifer, probably from past movement. Some trees exhibited multiple crooks suggestive of multiple episodes of ground movement. The size of the slide appears generally consistent with the 1996 AKS report, although not all limits of the slide are well-defined.

- Southwest of the home, a recent landslide was observed, again, centered on the stream that the subject landslide is centered on, but off of METRO property. This feature is labeled as Station 2 on Figure 2. This lower recent slide is defined by bare earth side and headscarps, similar to the subject side. The scarps expose similar soils and the soils and vegetation appear similar in type and age, suggesting that this lower slide happened approximately coincident with the subject landslide. Bowed trees are also present on this lower slide. The lower slide is on slopes that are about 50 to 60 percent gradient, on average.

- We did not observe other indications of recent landsliding at the site or nearby areas we traversed.
- When leaving the subject landslide, we observed a large graben feature, noted as Station 3 on Figure 2. Such a feature is typically associated with deep landslide movement such as that mapped southwest of the site.

- Complete road drainage improvements. As noted above, the existing road between the two drainages routes some water to the landslide area. The water could be routed outside of the subject landslide area and east of it. From our field reconnaissance, it appears that this option is feasible, but additional work would be needed to confirm grades are suitable and that the drainage to the east is sufficiently stable to receive the additional water. If this work is completed, it is expected to have a small stabilizing affect on the landslide. We do not have sufficient information to quantify the stabilizing benefit of these efforts, but we estimate it to be small. We would expect that the landslide area will still move in the future, even if this work is done. However, this measure may decrease the magnitude, severity and frequency of such movement.

- Install inclinometers in and adjacent to the landslide. Installing inclinometers has no stabilizing affect on the landslide. However, the inclinometer allows collection of data that would be needed for a more accurate understanding of the landslide and for use in mitigation. The inclinometers are also used to monitor the landslide to determine if it is expanding and/or movement is increasing which might indicate an increased threat to public safety.
