# LONE FIR CEMETERY

EXISTING CONDITIONS, RECOMMENDATIONS, AND FUNDING SOURCES

Portland Metro Sustainability Center

## **Lone Fir Cemetery Existing Conditions**

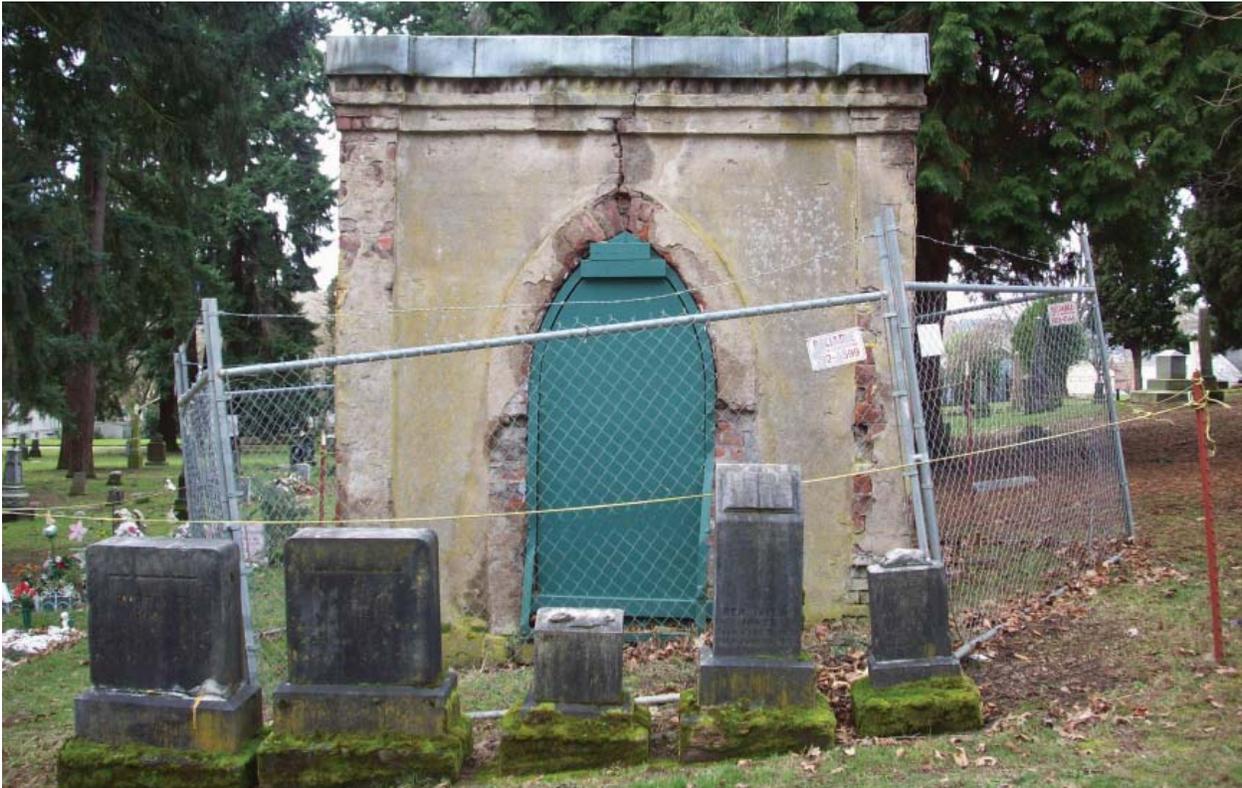
## Bottler's Mausoleum

The brick structure and partially stuccoed exterior walls of this mausoleum are in a very fragile state. A number of bricks have fallen off the parapet area of the walls. There is significant cracking and separation of wall material on all four sides. Additionally, it appears that portions of the roof are missing. Friends of Lone Fir Cemetery records indicate that there are no caskets inside the building. This mausoleum is currently surrounded by a cyclone fence because it is hazardous as it stands.

Contact the structure's owners/stewards to obtain their long-term intent for its operation and maintenance. Retain a structural and/or architectural historical evaluation of the structure. Abate life-safety issues and repair it as a "stable ruin", as one of many options.

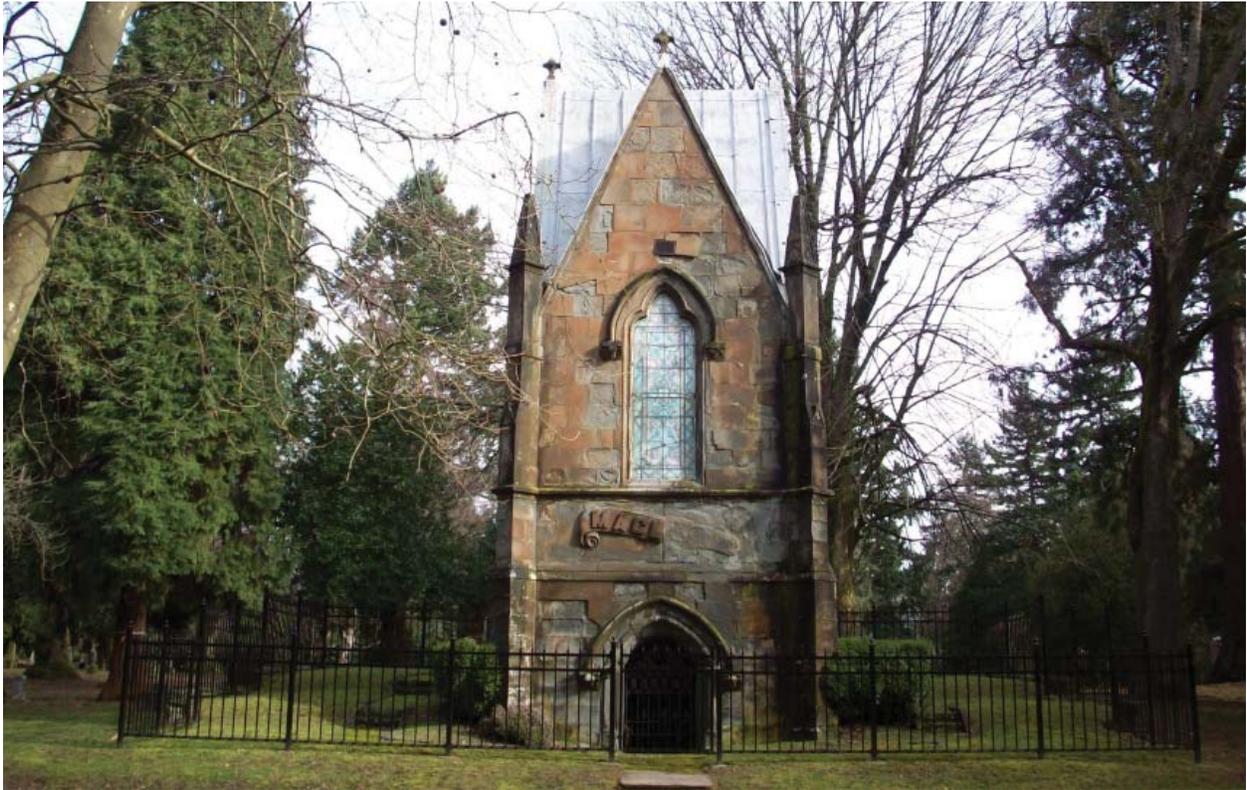
## Macleay Mausoleum

The mausoleum's façade appears to be comprised of a fine grade sandstone veneer over a coarser sandstone material. A significant number of veneer stone panels have fallen off the structure. Further deterioration and failure of the veneer and backing stone and the raised letters of the Macleay name is occurring. At the northeast corner, plants are growing in the structure and a finial is about to tip over. A rolled-seam metal roof appears to be covering another roof structure and is in a deteriorated state. Stained and leaded glass windows have been removed and replaced with a painted faux stained and leaded glass covering. A newer black powder-coated metal fence with a gate on the west elevation surrounds the mausoleum. There appears to be a missing stone structure of some kind, because a portion of the base still exists.

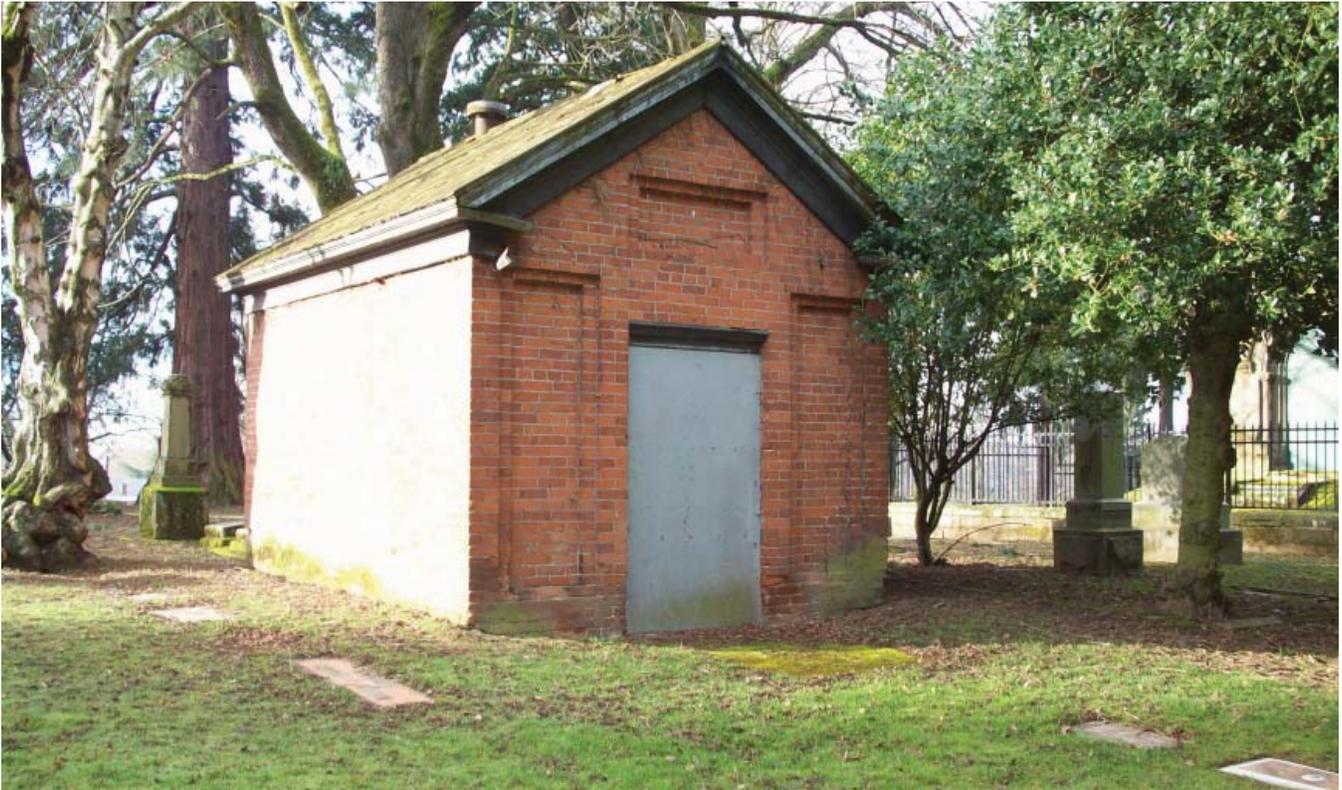
### Holding Structure Near Macleay Mausoleum

This building consists of brick walls and a stamped metal roof with a metal vent. There appears to be plant material growing from inside the structure through edges of the metal roof. The building appears to be in stable condition. The building is in the process of being donated to the Friends of Lone Fir Cemetery to be used for monument cleaning and restoration.

It is recommended that the plant material growing through the roof be removed so that it does not cause additional damage to the structure. It is also recommended that a French drain be installed around the perimeter of the building to resolve drainage issues at the base of the structure.

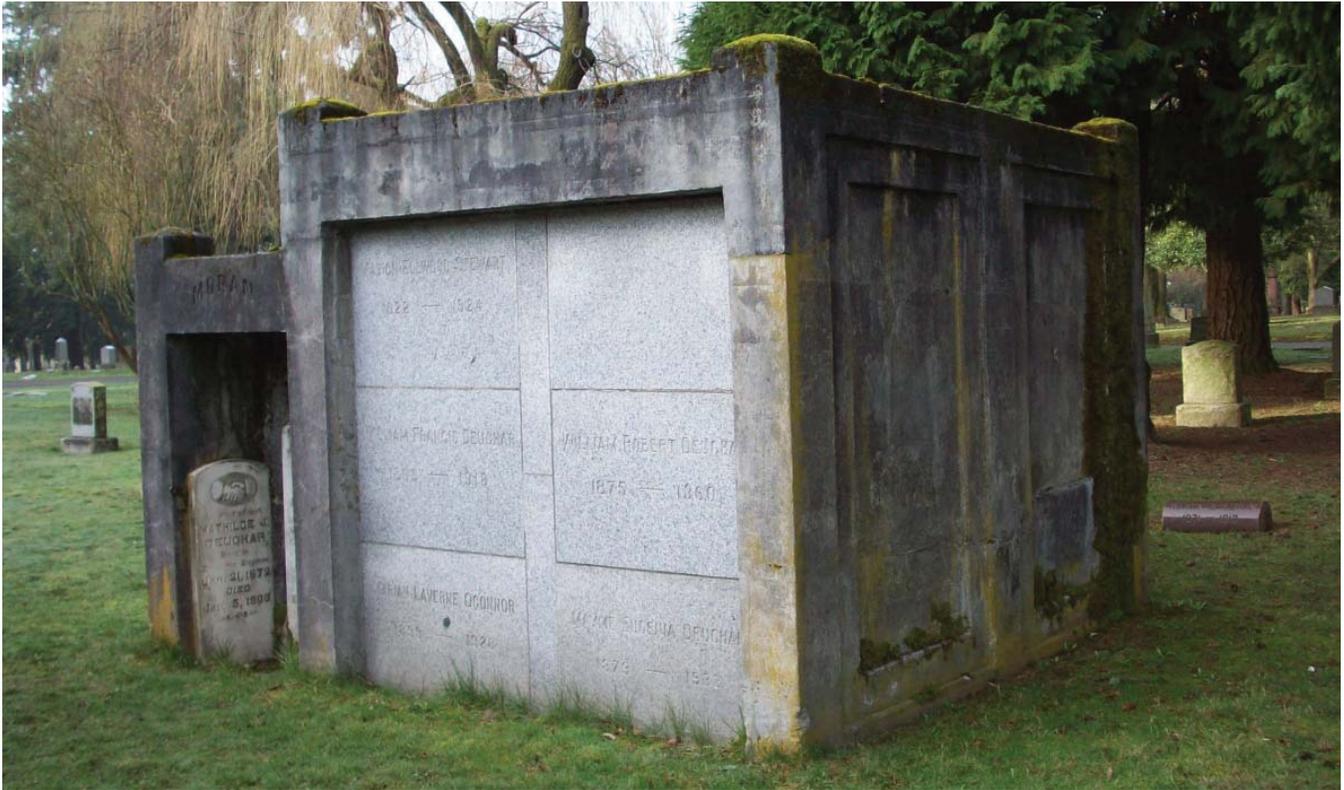
## Moran Mausoleum

This poured-in-place concrete mausoleum structure appears to be in stable condition even though some horizontal cracking in the walls is evident. Moss growth is causing deterioration on the north wall face. A wrought iron gate is missing.

Remove the moss and carefully clean the structure. Contact of the structure's owners/stewards should be made to obtain their long-term intent for its operation and maintenance. There is currently a problem with visitors climbing on the top of this structure. It is recommended that some type of climbing deterrent that does not visually detract from the structure be added to prevent future occurrences.

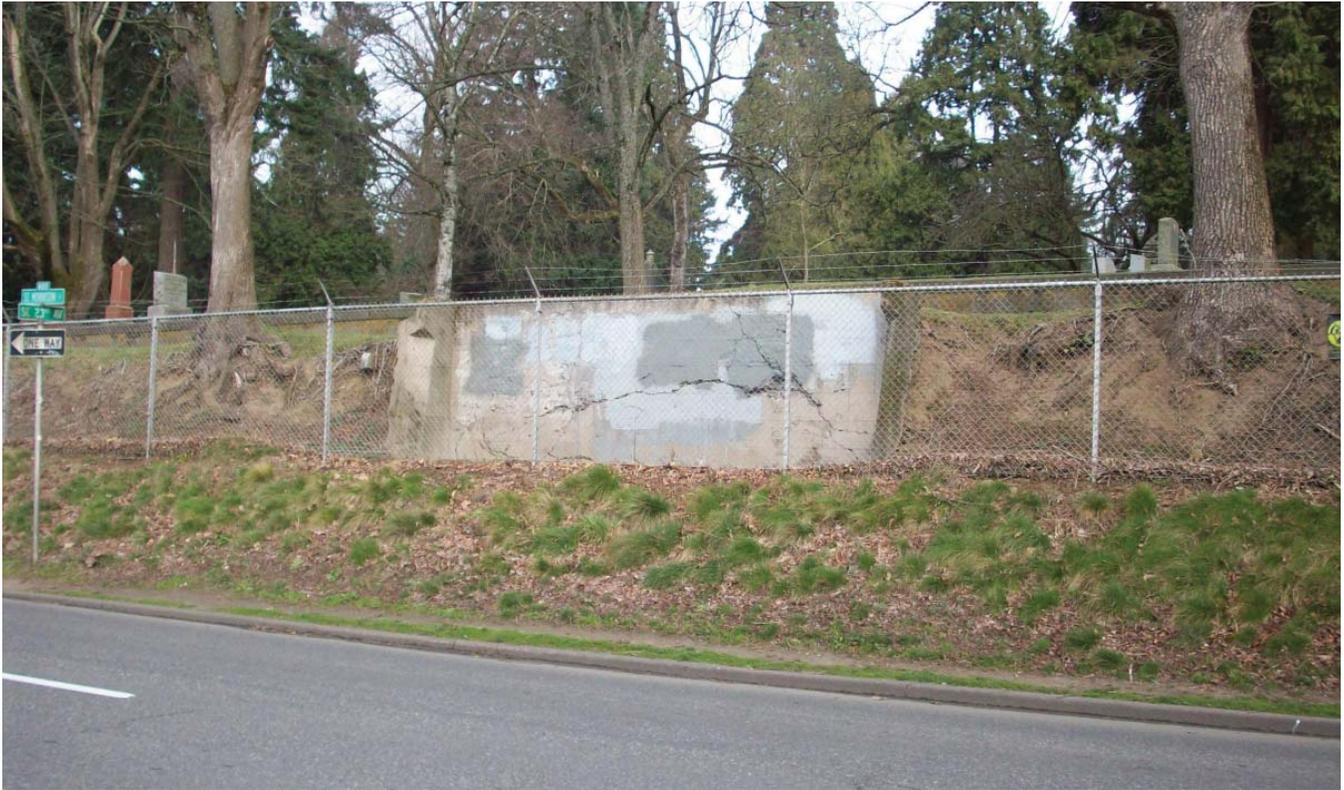
## Trolley Station Remnant

Along the south side of the cemetery, at the intersection of SE 23rd Ave. and SE Morrison St., there is a remnant wall of a concrete structure believed to be part of an old trolley station. The concrete is badly cracked. Approximately five trees on either side of the concrete remnant have significantly exposed roots due to soil erosion.

Because this wall is a remnant of a structure from the cemetery's historic period, 1854-1957, it is recommended that further research be done to assess the structure's historic use. It is also recommended that the structure be preserved as a stable ruin. Some rehabilitation work will be required to stabilize the cracking that has occurred, and it is recommended that the wall be evaluated for structural integrity. The trees have been evaluated by an arborist, and are considered stable. However, additional canopy pruning is recommended. A property survey of the south cemetery boundary should be implemented to ascertain ownership and liability. The existing perimeter fencing should be replaced with a 6' high powder-coated metal fence in the same style as the Macleay Mausoleum fencing. New perimeter fencing should coincide with the cemetery property line, if feasible.

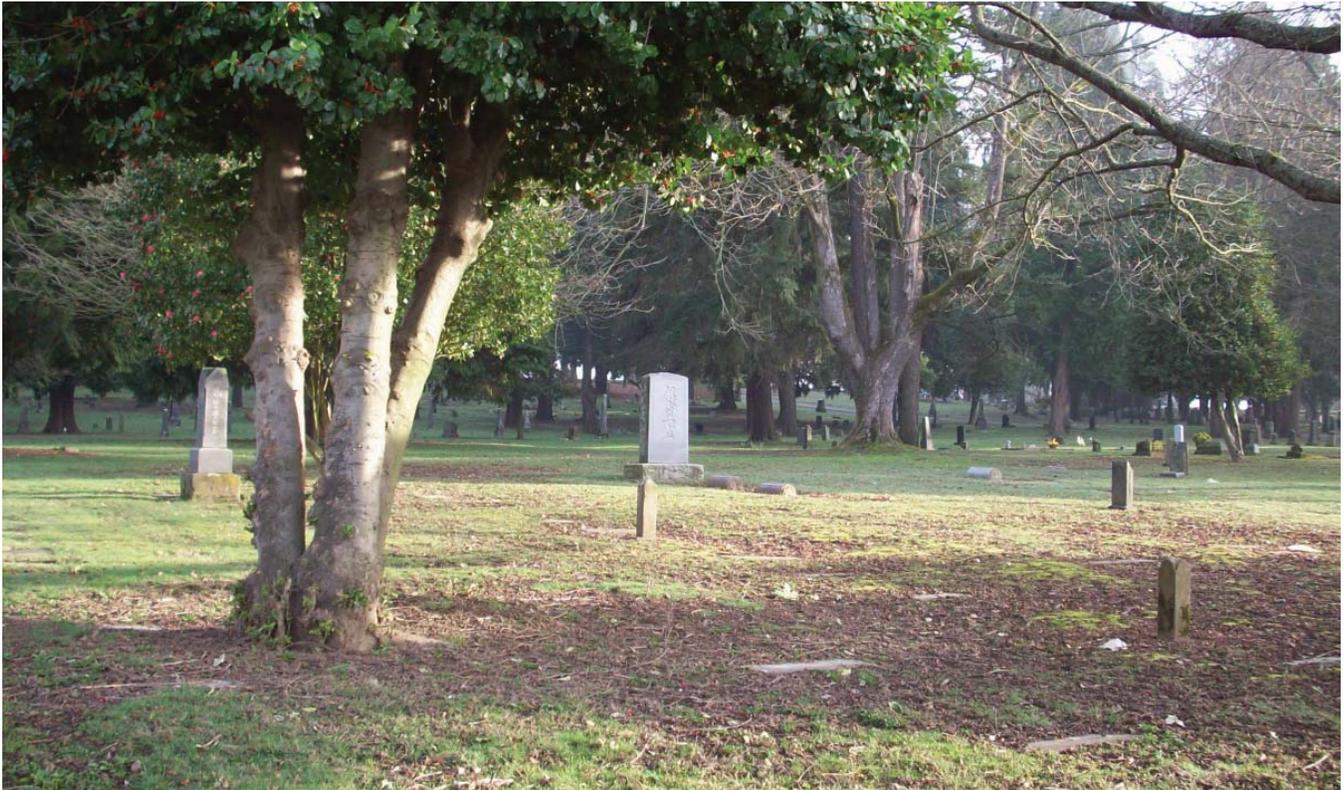
## Japanese Section

The Japanese Section of Lone Fir cemetery is located in Block 11, in the southwest corner of the cemetery, adjacent to the north side of Block 14 -- the historic Chinese section of the cemetery. The Japanese section is an area where burials still occur. It includes a stone memorial currently used by visitors. A number of significant trees exist in this area including a very large Camellia and Oak. Both appear to be quite old and in good condition.

Preserve the character of the Japanese Section as it exists. Ascertain if there is a cultural organization that has an interest in the long-term operation and maintenance of this section. It is recommended that a stone sign be added to this section to locate it for visitors. The new sign should be in the same style as all future signs for notable cemetery sections. Additionally, a local Buddhist organization is looking to locate and fund a columbarium within the cemetery. The west edge of the Japanese section, between the road and the western property line, may be a suitable location.

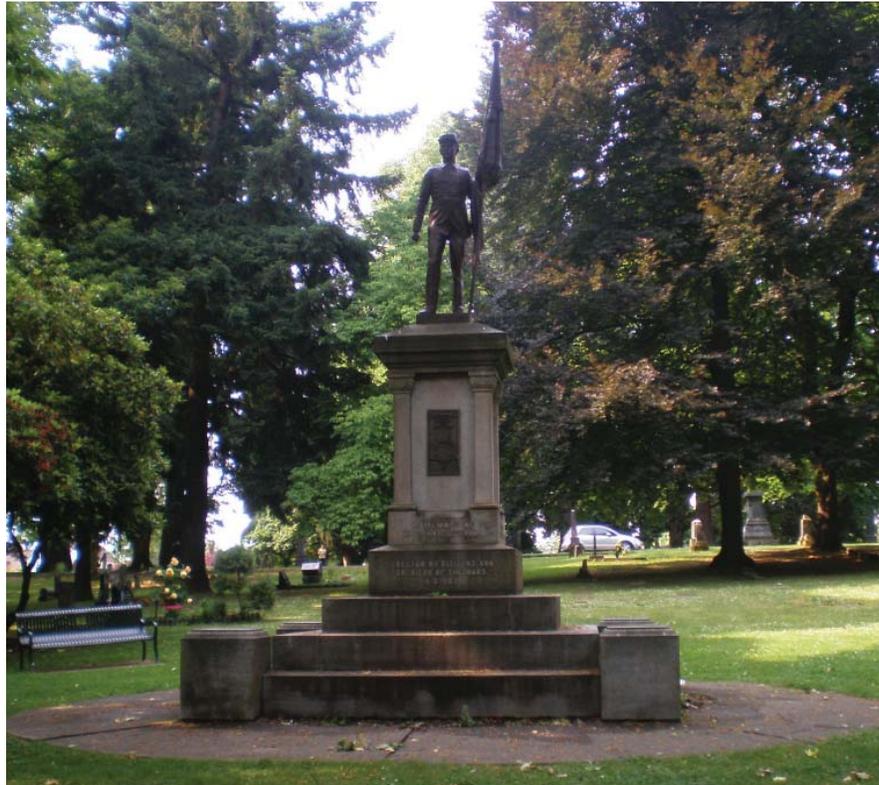
## War Memorial Park/Soldiers Memorial

The cemetery's 1944 amended plat map designates the area around the Soldiers Memorial as a public park. The existing area of this delineated park contains the classic single monolith Soldier's Memorial, three donor benches, and a later addition concrete slab that is currently being used for funeral services. The Soldier's Memorial is made of granite with a bronze statue and bronze plaques. It is in stable condition, although the soil appears to have eroded away at the base, exposing some of the foundation in places.

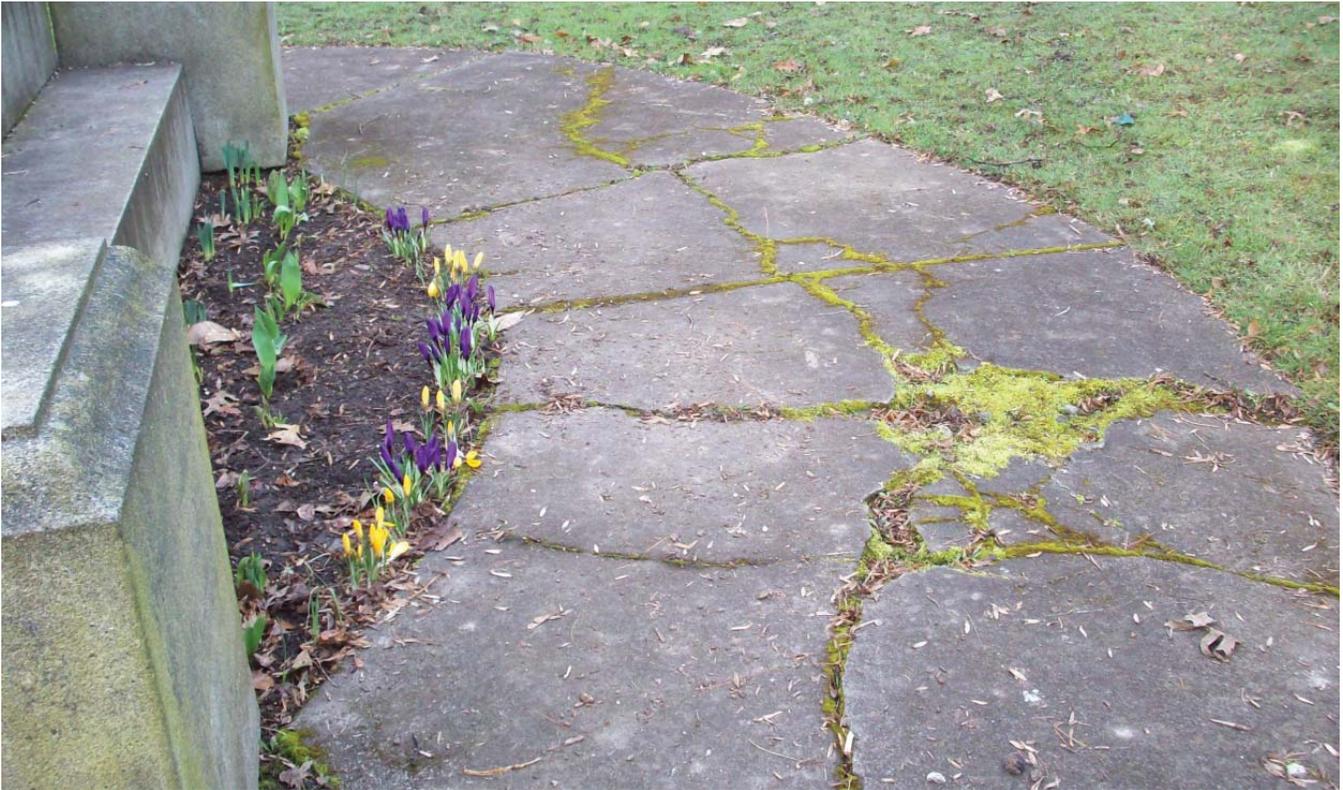
### Cracked Pavement at Soldiers Memorial

The above photo indicates the bareness of the plant beds, and the extent of cracking in the concrete pavement at the base of Soldiers Memorial. Additionally, the ground around the base of the memorial has subsided, so that a gap between the memorial and ground exists in some areas.

Remove the existing concrete paving and plant material. Regrade the area around the memorial so that the new paving will hide the exposed base of the memorial. Add a new concrete paving skirt and infill the current planting areas with sand-set granite pavers in a color complimentary to the memorial.

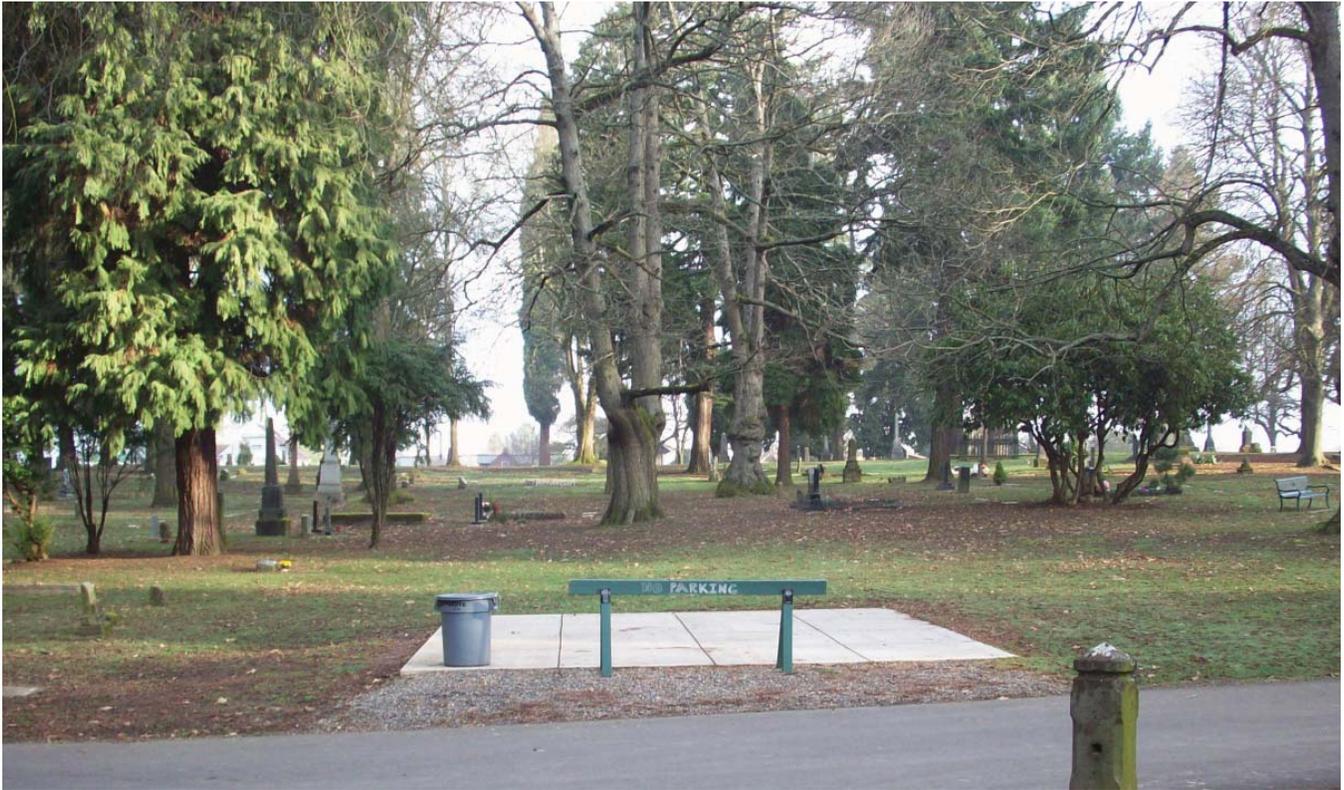
### Concrete Pad at War Memorial Park

A roughly 20' X20' concrete pad was recently added west of the Soldiers' Memorial. The concrete pad is in good condition, and is currently being used for services by all cemetery patrons. It is understood that there is a desire for an overhead trellis-like structure in this location to protect cemetery patrons from the elements during funeral services. Additionally, it is understood that there is a need for a maintenance shed and an employee rest room in the cemetery. The cemetery's 1944 amended plat delineates a large area in this location as "reserved for building site."

It is recommended that an overhead trellis structure be provided over and around the concrete pad because of its central location and historic delineation. To meet the Secretary of the Interior's Standards for a National Register Property, the trellis-like structure should be similar to the other cemetery structures in scale, material and design. A maintenance structure and employee rest room are not recommended for this site because of the extent of site disturbance due to excavation for the structure, plumbing and electrical that would be required for their construction.

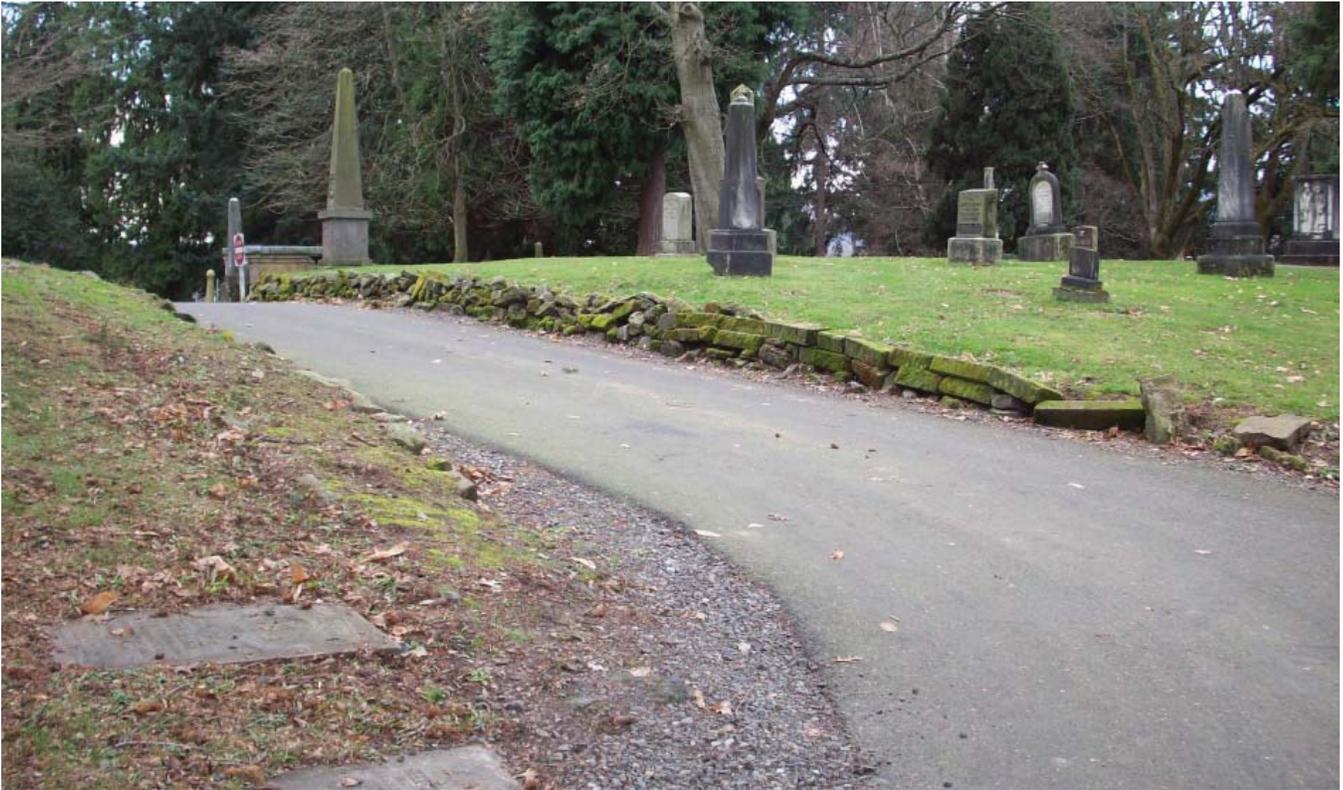
### Northwest Rubble Wall

In the northwest corner of the cemetery, near the earliest graves, low stone rubble walls make up the grade difference between plots and road/pathways. Mixed in with the rubble stones are more rectangular pieces of stone; these pieces appear to be old headstone bases. In some locations the rubble walls appear stable, in other locations the stone is loose or has been removed.

It is recommended that the unstable stonework be realigned and set securely, and the gaps in the stone wall be filled in with similar stone material to match the appearance of the existing wall.

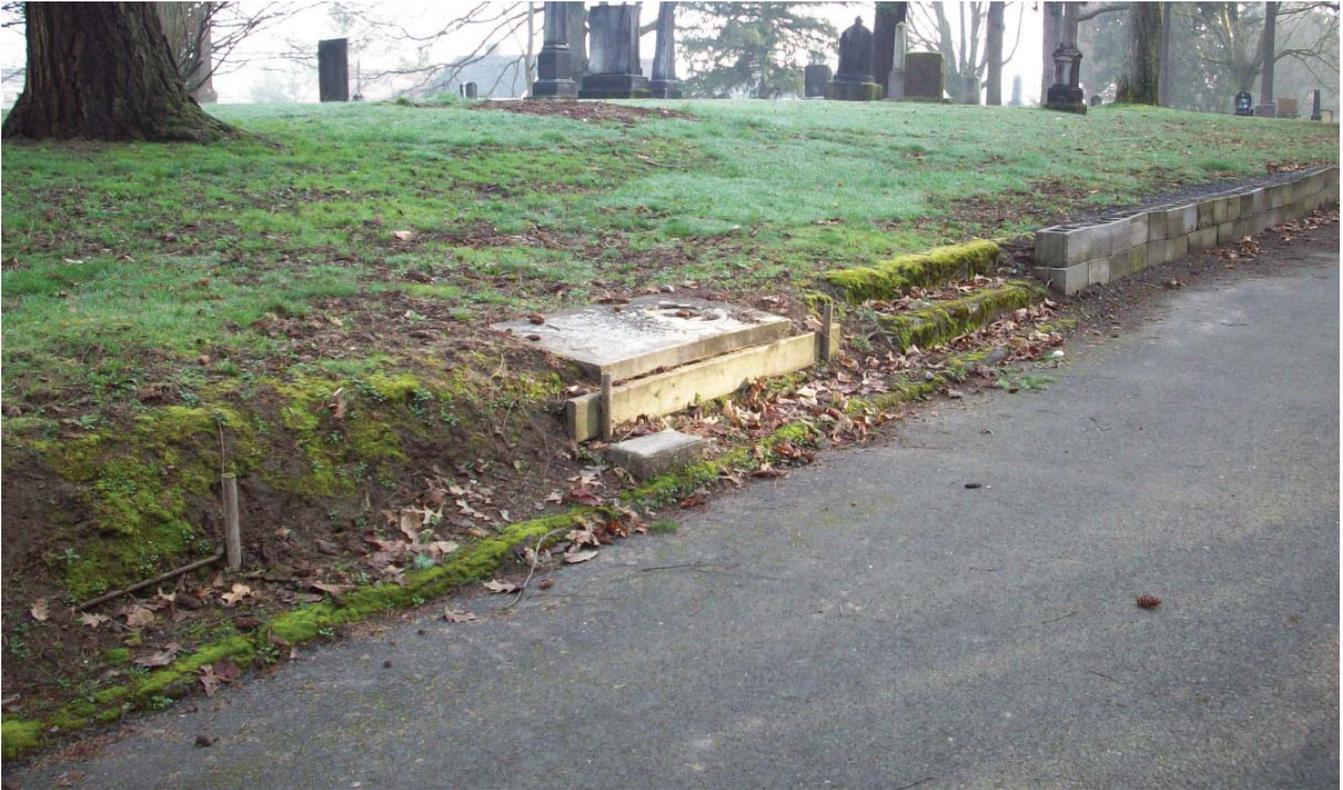
### Deteriorating Wall Condition Near Grave

One section of rubble wall in the northwest corner of the cemetery has been removed and replaced at some point with a concrete wall. Very little of the replacement wall remains. There is a newer patch of concrete masonry units (CMU) block in one portion of the wall. Additionally, the side of a grave is exposed where there currently is no wall. Near the exposed grave, there is a marker stone at the base of the old wall. It is not known if this marker stone is indicating an actual grave, or was previously moved from another location.

Remove the CMU block and remainder of deteriorated concrete wall. Replace it with a rubble stone wall that closely matches the appearance of the adjacent rubble wall. Ensure that neither the grave nor the stone marker at the base of the grave are disturbed. Restore and reinstall the headstone in its original vertical position.

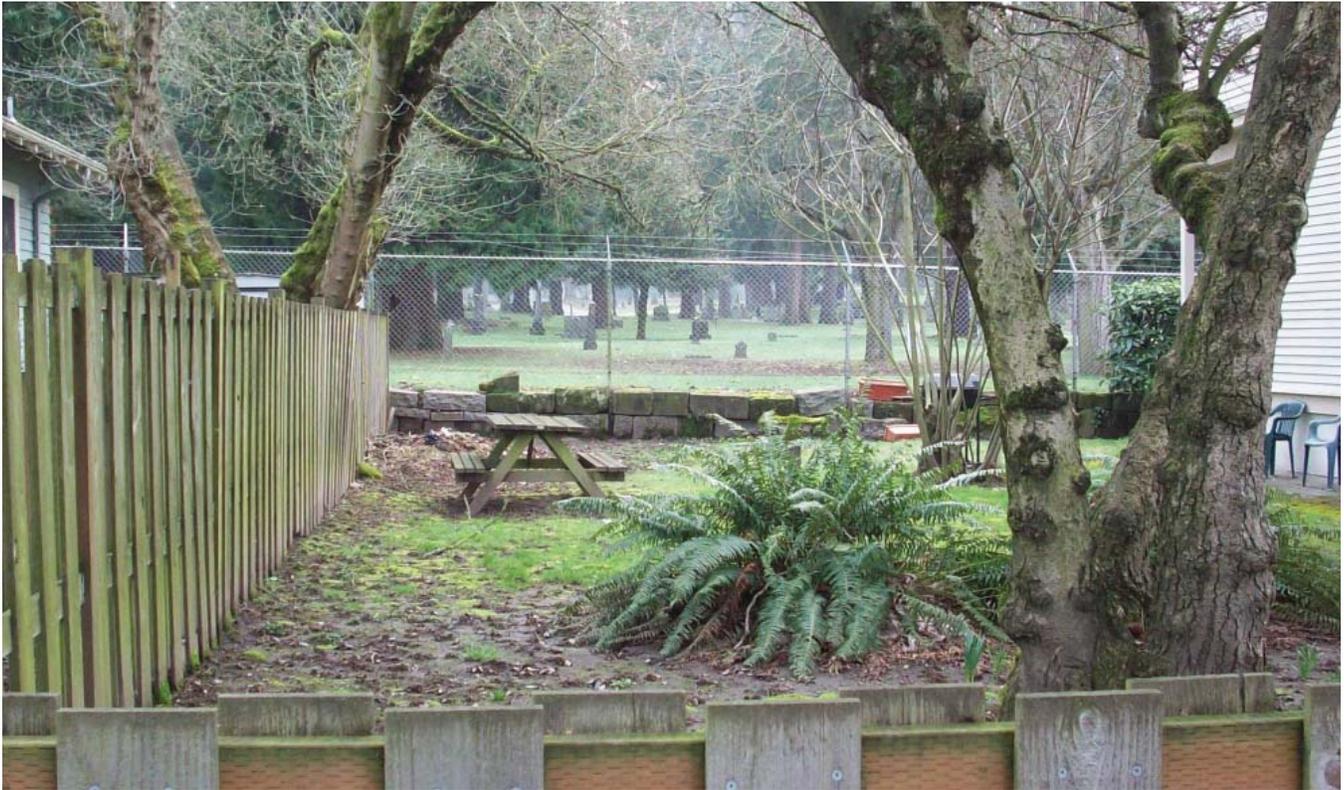
### West Rubble Wall

A low stone rubble retaining wall exists along the western boundary of the cemetery, adjacent to residential properties along SE 20th Avenue. The rubble stones in the wall appear to be mixed with old headstone bases. The wall appears to be in a stable condition.

Leave the stone rubble wall intact.

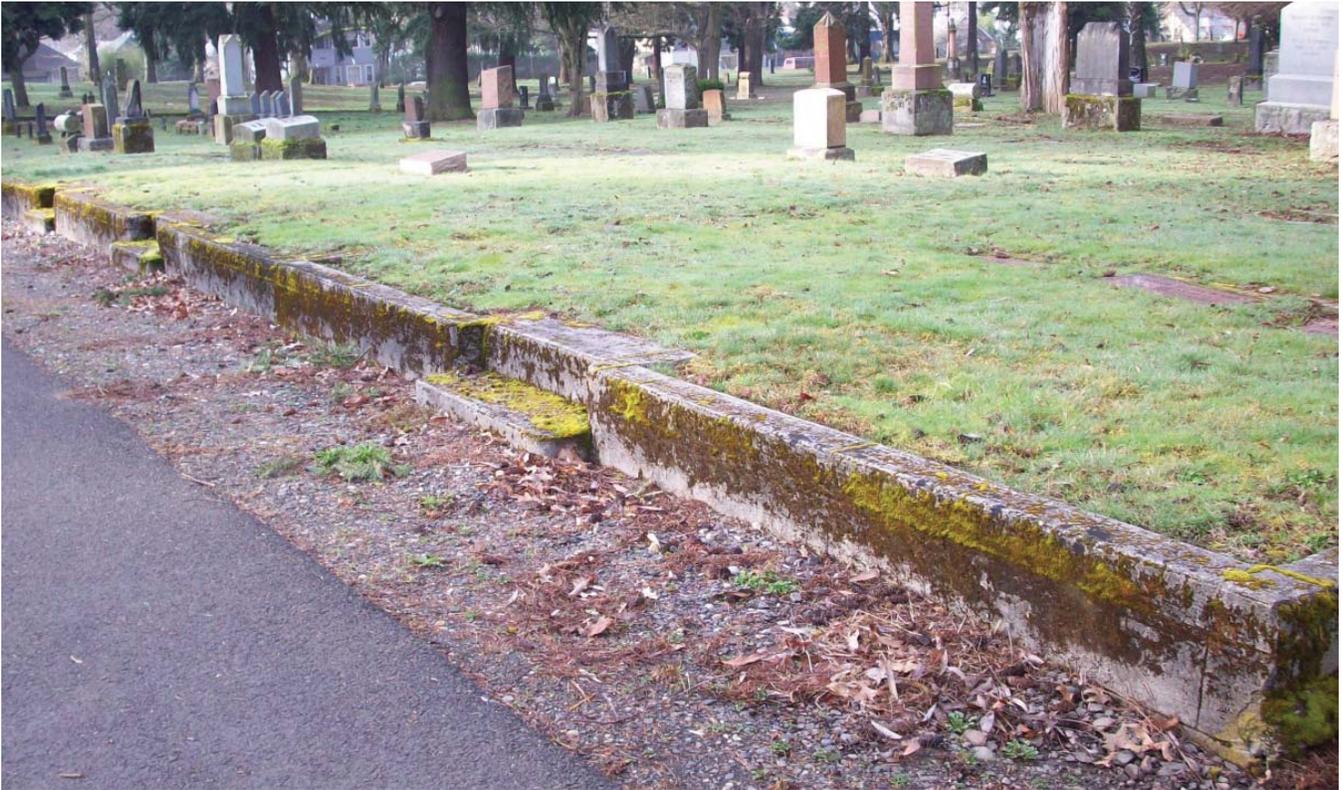
### Interior Concrete Wall With Step

In a number of places within the cemetery there are low concrete retaining walls with steps that lead to the cemetery plats. These walls appear to be in a stable condition.

Leave these interior concrete walls intact. Clean the moss as necessary to prevent deterioration of the concrete.

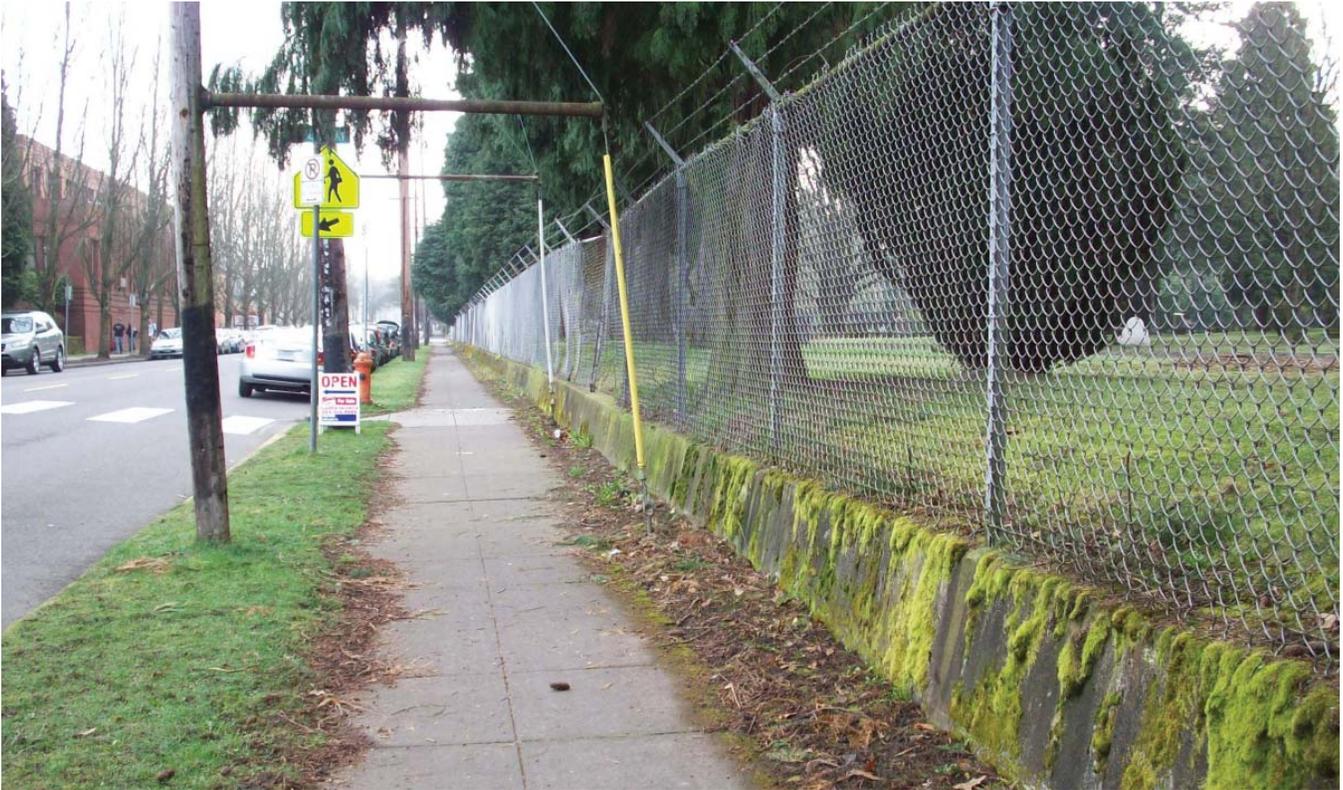
### North Concrete Retaining Wall and Fence (Eastern Half)

The north concrete wall along its eastern half is much lower, averaging 2' in height, and appears to be in stable condition. Moss is growing on most of the wall. A cyclone with barb wire fence is located on top of the wall. It is in fair to poor condition.

Clean the moss off of the retaining wall so that it does not cause damage to the surface of the wall. The cyclone and barb wire fence is not appropriate to the character of the cemetery. The existing perimeter fencing should be replaced with a 6' high powder-coated metal fence in the same style as the Macleay Mausoleum fencing. New perimeter fencing should coincide with the cemetery property line, if feasible.

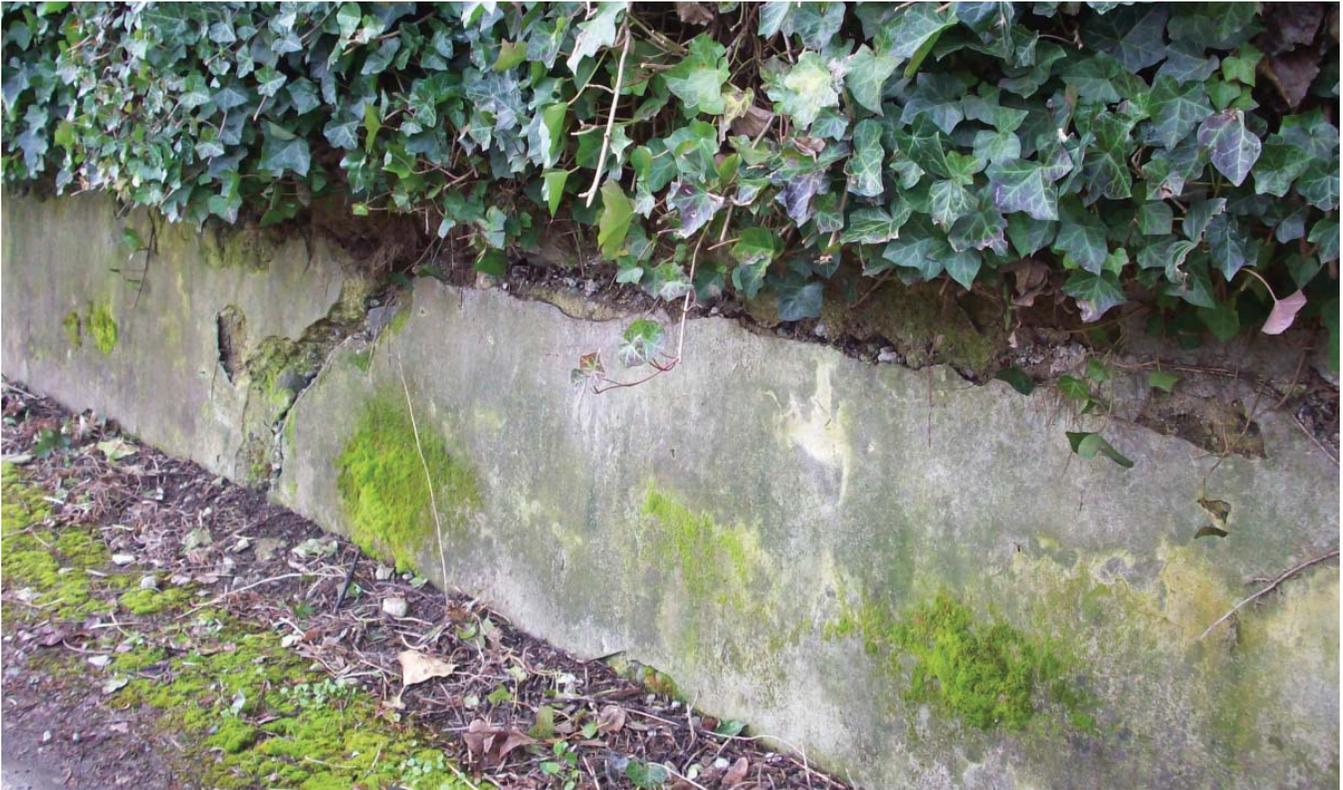
### North Concrete Retaining Wall Damage

Ivy growth is causing damage to the surface of the concrete retaining wall, as is evident at the lower edge of the ivy in the above photo. Periodically, there are large vertical cracks through the wall.

It is recommended that the wall condition be reviewed by a structural engineer to make recommendations for wall repair techniques, soils loading, and drainage that will preserve the wall to the greatest extent. The ivy should be kept trimmed back from the wall so that it does not cause further damage, until it is ultimately removed and the wall is repaired or replaced.

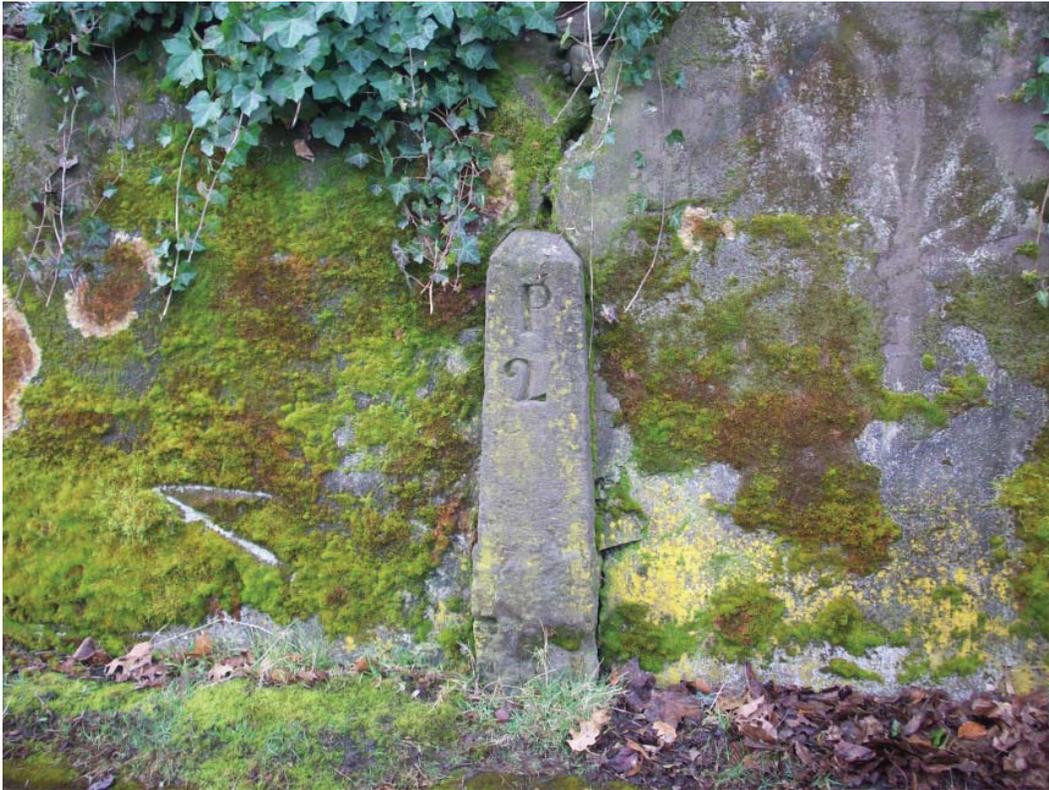
### Baseline Road Mileage Marker (Stark Street)

An original Baseline Road mileage marker (milestone) exists in the concrete retaining wall at the north edge of the cemetery. The characters "P2" were inscribed in the face of this marker to indicate that the city of Portland was 2 miles further along the old Baseline Road. It is believed to have been moved slightly from its original location when Stark Street was widened. The concrete retaining wall around it is cracked vertically.

As one of the oldest monuments on the site, this mileage marker should be preserved, and protected if any future wall repair work is done around it.

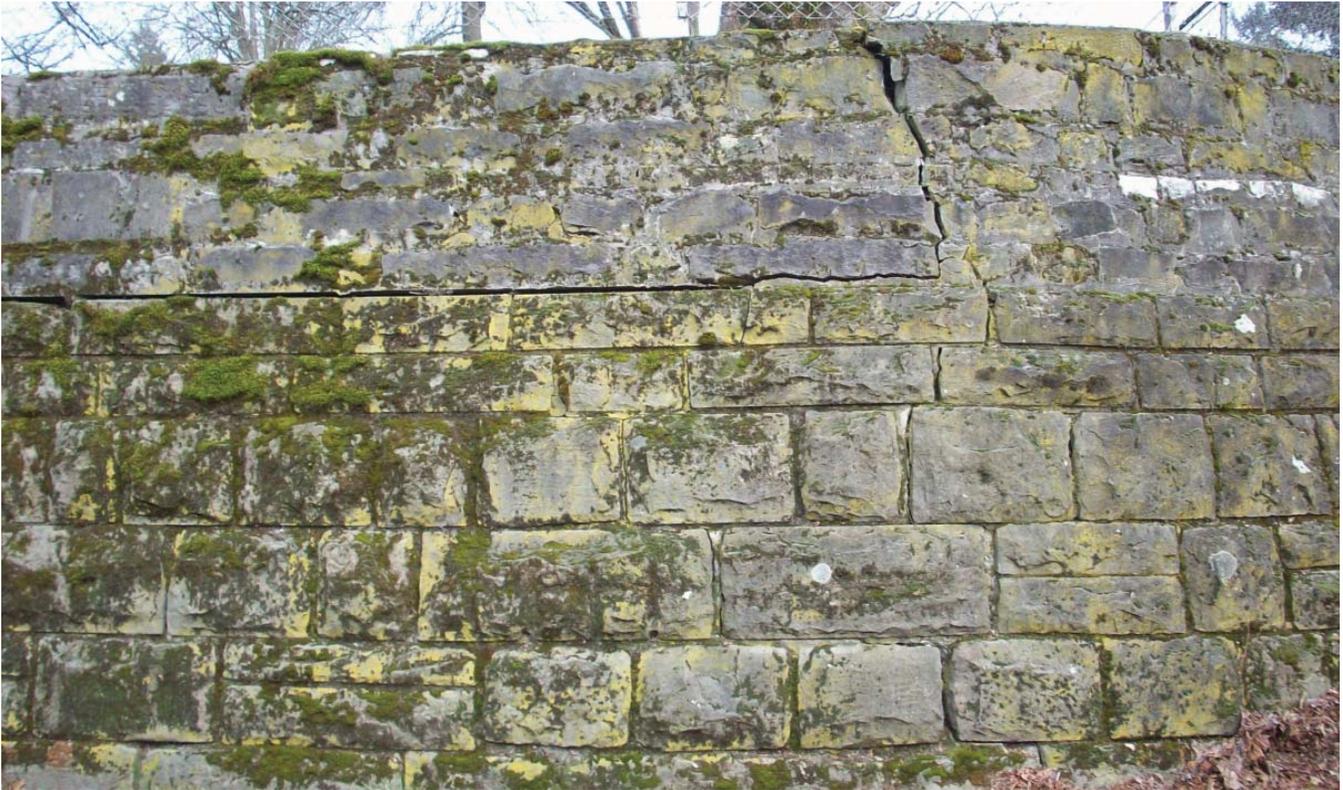
### Cracking at Corner of Southeast Basalt Wall

At the southeast corner of the basalt wall, a significant crack has formed in the jointing of the stone.

The crack should be evaluated by a structural engineer. The wall should be preserved, and reset if necessary to achieve stability; however, the cause of the stone dislodging should be investigated and the soils and drainage conditions above should be considered before any stone work is implemented.

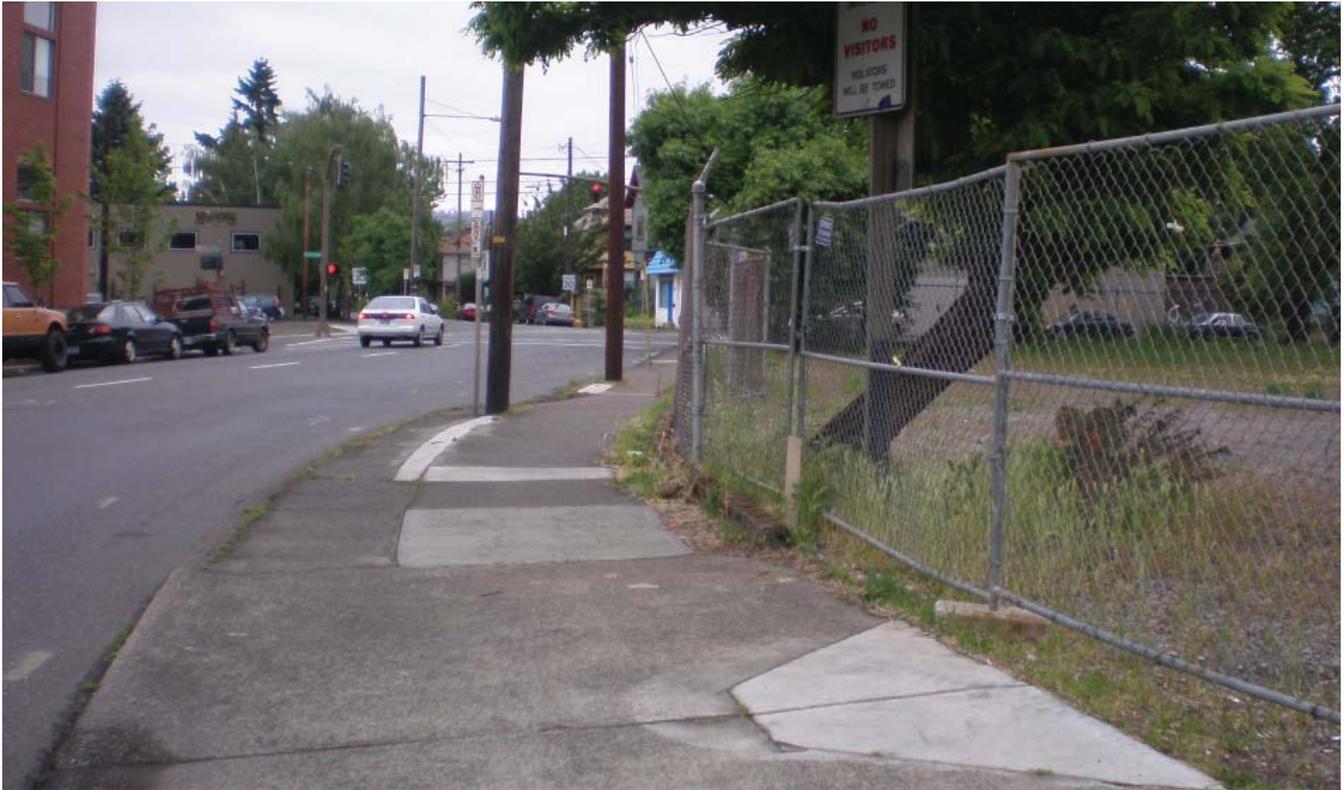
### Sidewalk at SE Morrison Street and SE 20th Avenue.

The sidewalk at SE Morrison and SE 20th is cracked and does not meet City code requirements. There are very few street trees along the Morrison Street property edge, and they are in poor condition. There are no street trees along the 20th Avenue property edge. The curb ramp at the corner of SE Morrison and SE 20th does not have required tactile warning. The site is currently fenced with temporary chain-link fencing.

As part of the Morrison Property improvements, the sidewalk adjacent to cemetery property at SE Morrison and SE 20th will need to be brought up to current City code requirements. Improvements to this sidewalk should include the removal of three driveway curb cuts, extension of the sidewalk to a 6' width, the addition of street trees at regular intervals, and the addition of tactile warning on the curb ramp at the intersection. Additionally, tactile warning needs to be added to the curb ramps at the corner of SE Morrison Street and SE 26th Avenue, and the corner of SE 26th Avenue and SE Stark Street. The existing perimeter fencing should be replaced with a 6' high powder-coated metal fence in the same style as the Macleay Mausoleum fencing. New perimeter fencing should coincide with the cemetery property line, if feasible.
