# LONE FIR CEMETERY

EXISTING CONDITIONS, RECOMMENDATIONS, AND FUNDING SOURCES

Portland Metro Sustainability Center

## **Lone Fir Cemetery Existing Conditions**

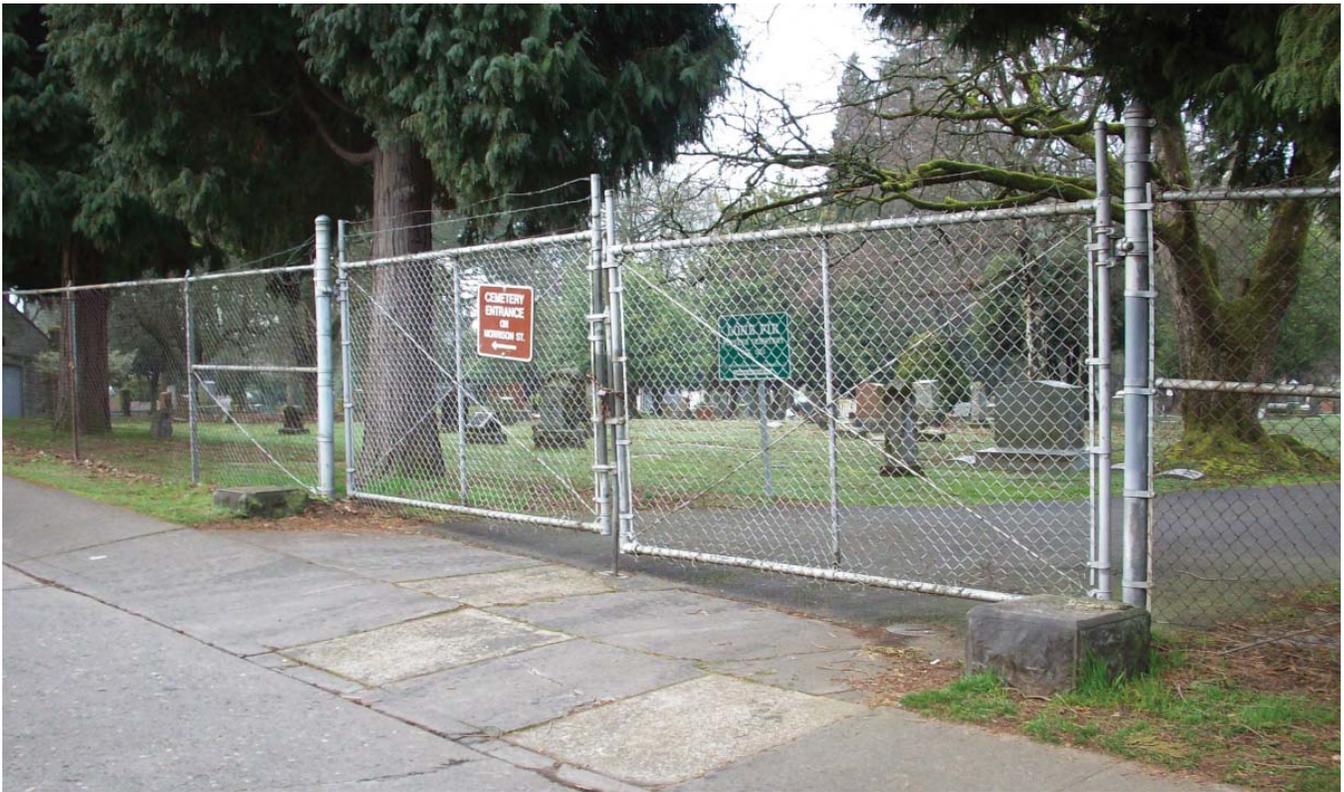
## East Gateways

Two cemetery entrance gateways are located on the north side of SE 26th Avenue. These gateways were most likely also flanked with basalt columns similar to the ones that exist at the west gateway on SE 20th Avenue, because two remaining basalt bases flank each entrance along SE 26th Ave. The driveway is cracked and crumbling in places.

It is recommended that new basalt columns be installed similar in material and appearance to the basalt columns on SE 20th Ave. The existing perimeter fencing and gateways should be removed and replaced with a 6' high powder-coated metal fence in the same style as the Macleay Mausoleum fencing. New perimeter fencing should coincide with the cemetery property line, if feasible. It is recommended that the gates be of the same style as the fencing, power-operated and timed to open during the day and close at night. The driveways should also be repaved.

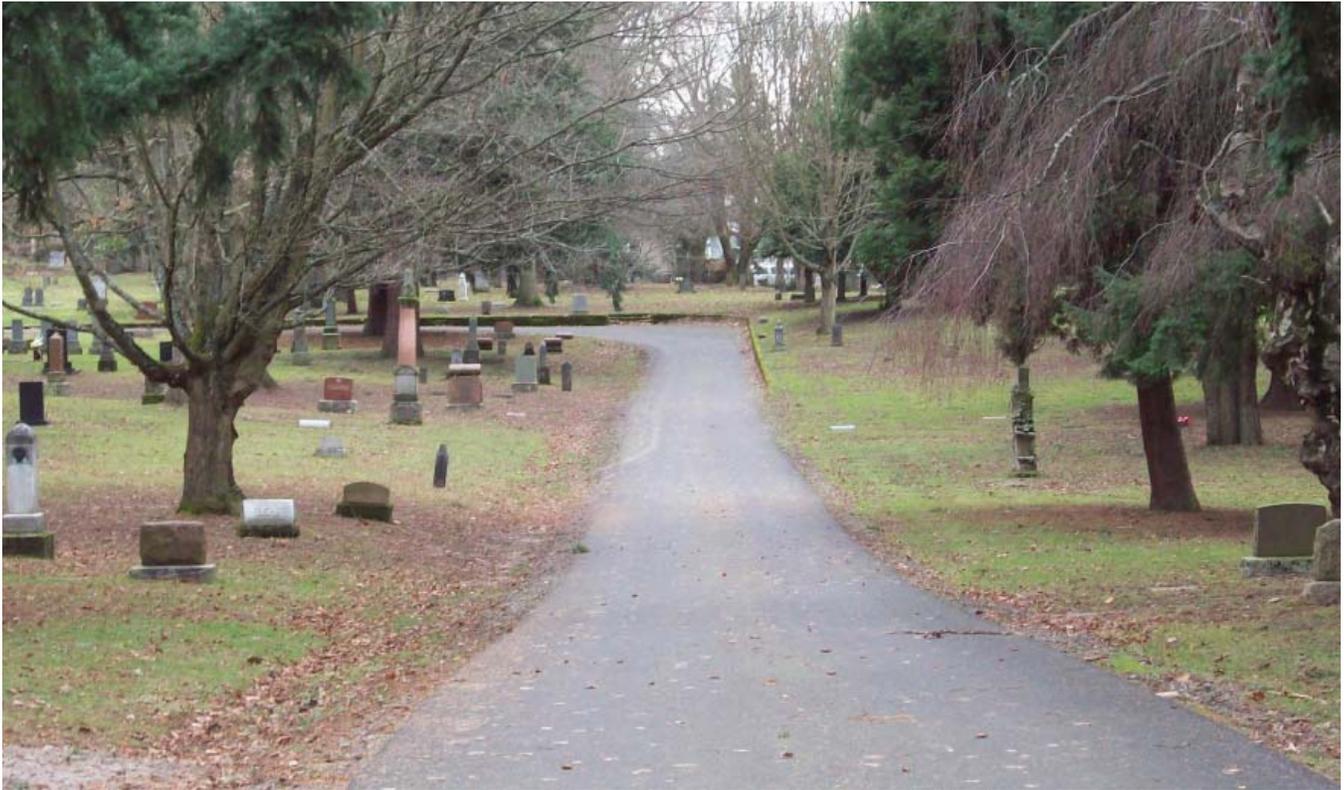
## Asphalt Path

The pathways throughout the cemetery are all paved in asphalt and range in width from 12' to 18'. Prior to being paved in asphalt, historic research indicates that these pathways were gravel roadways. The paths are used primarily by pedestrians, and occasionally by cars that drive in and park near graves. The paths are crowned and drain into gravel edges. All pathways appear to be in good condition.

Because there is no record of the paths being paved in any other material other than gravel, and it is not desired that they be repaved in gravel rather than asphalt, it is recommended that they be left as is.

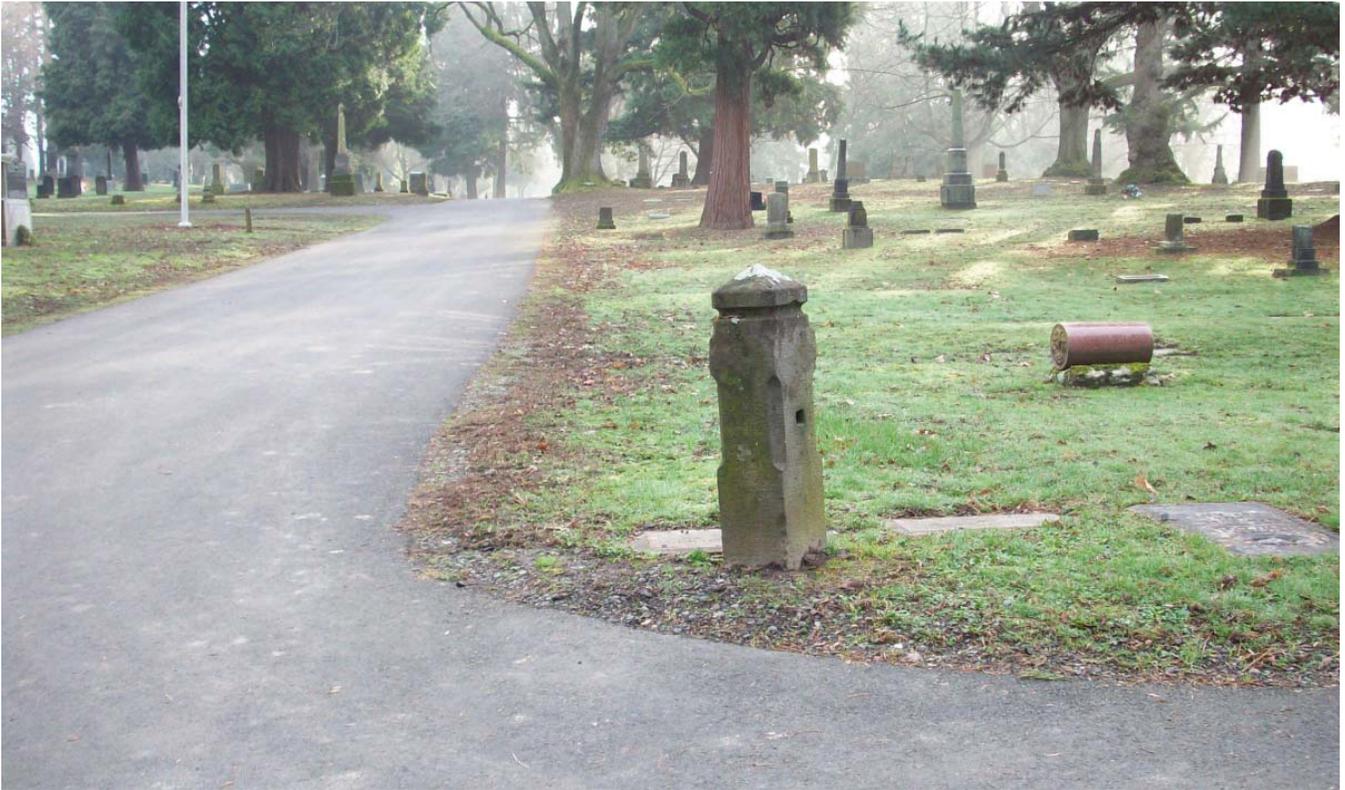
## Gateway Column

Along the asphalt path in the center of the cemetery there is one half of a rectangular gateway column. There is no known historical information regarding interior gateways in the cemetery. It appears to be in good condition.

It is recommended that the gateway feature be left intact.

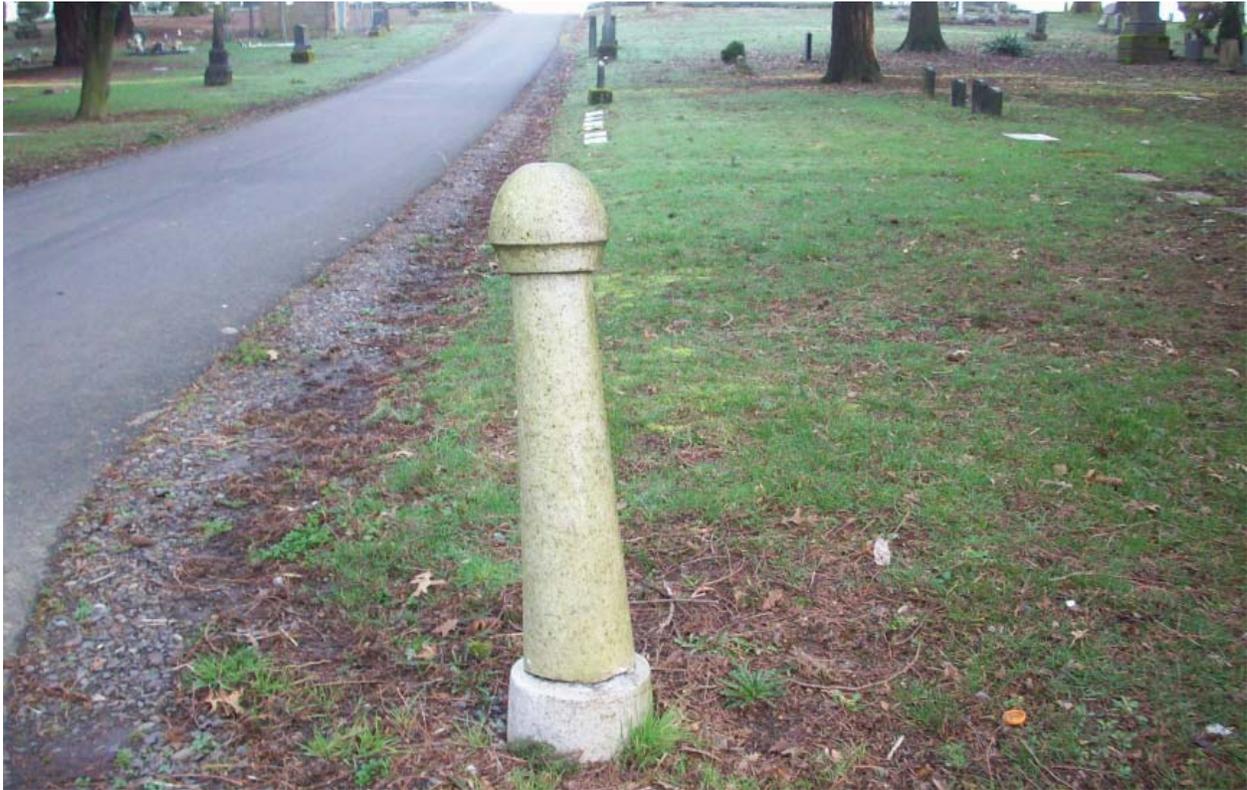
## Gateway Bollard

Along the asphalt paths in the center of the cemetery there are round gateway bollards. There is no known historical information regarding interior gateways in the cemetery. They appear to be in good condition.

It is recommended that the gateway bollards be left intact.

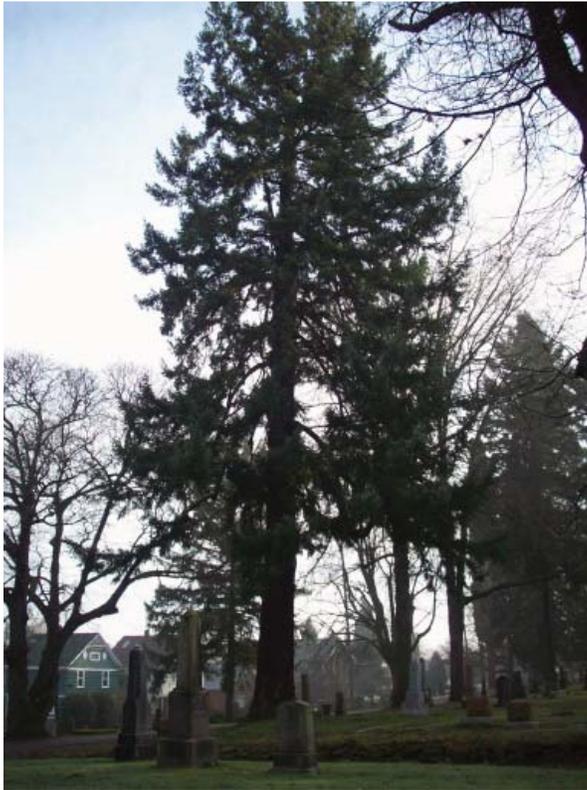
## Lone Fir / Cemetery Trees

The original Douglas fir tree that the cemetery was named after still exists in the northwest corner of the cemetery. The tree appears to be in fairly good condition, although there are some large growths on its trunk about midway up, and the top of the tree has broken off. The cemetery contains over 30 acres filled with mature trees of many diverse species, giving the cemetery an arboretum-like character.

The Lone Fir tree and all other cemetery trees should be monitored by an arborist on a regular basis to evaluate their biological health and structural integrity. Further, it is recommended that the trees of the cemetery be mapped and identified with the size and species of each.
