ADAPTIVE REUSE CASE STUDY

City of Oregon City, Historic Downtown Oregon City,
Metro, and Multnomah Lodge No. 1

MULTNOMAH LODGE NO. 1 OVERVIEW

BUILDING AND CODE REVIEW

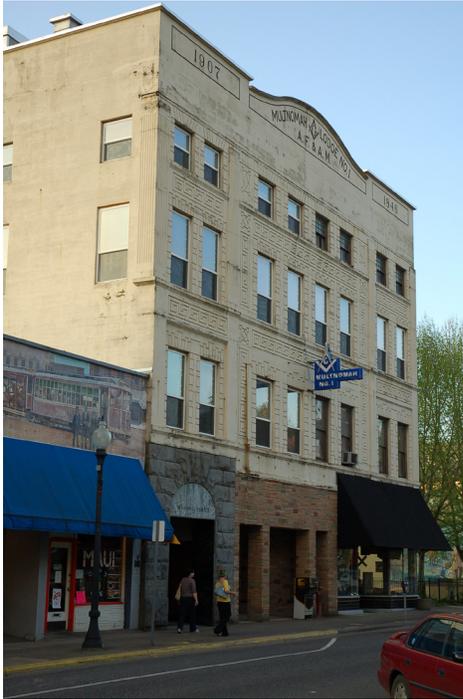
Multnomah Lodge No. 1, pictured to the left, is located in Oregon City and is downtown's tallest building. It was the first Masonic Lodge established west of the Rocky Mountains. The lodge itself was chartered in 1846, and this particular building was constructed in 1907.

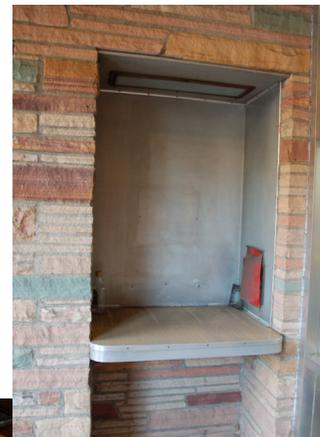
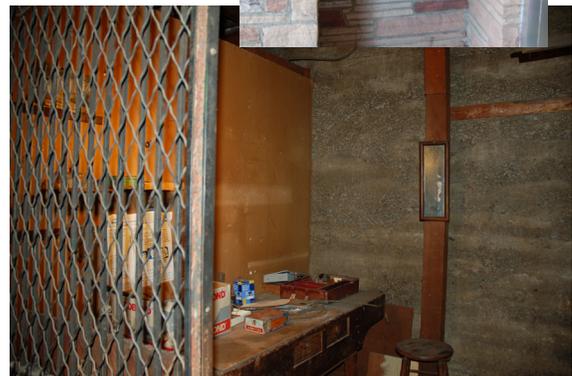
Telegraph Office Window and Operator Cage

This building has always been a mixed-use structure that was integral to the workings of the city. In its past, the basement alone has served as the city library, the morgue, a television station, and the telegraph office, according to current lodge members. In an alcove accessible from the recessed retail storefront at ground level (which still exists to this day and is pictured below) a customer could make a telegraph purchase, and it would be passed down to the operator in the basement through a chute. The telegraph cage is still in its original place in the basement below the building.

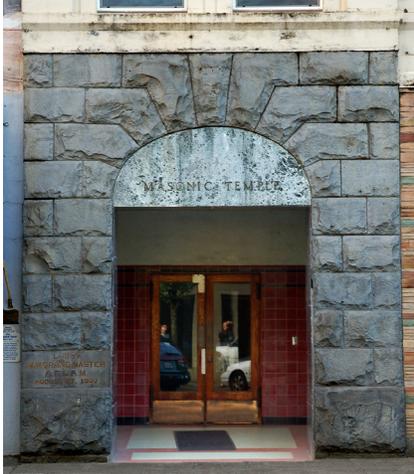
The front exterior facade of the building features geometric patterns cast into the surface of the building, with vertical fluted pilasters on the exterior as well. It is considered to be exotic revival in terms of architectural building style, according to the historic survey forms.

The Main Street entrance to the upper floors, shown to the left, features a dramatic archway constructed of rough hewn stone work. Walking through the archway leads visitors to recessed double doors, which serve as a transition to

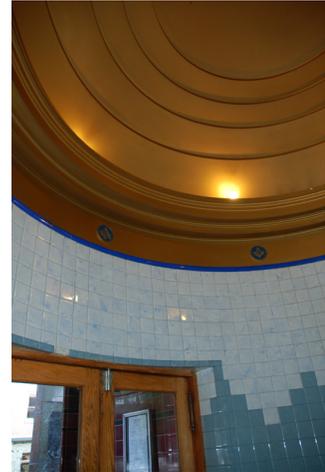
a tiled rotunda, pictured on the bottom right. The lobby, main staircase, and the elevator are accessed by traveling through this circular room.

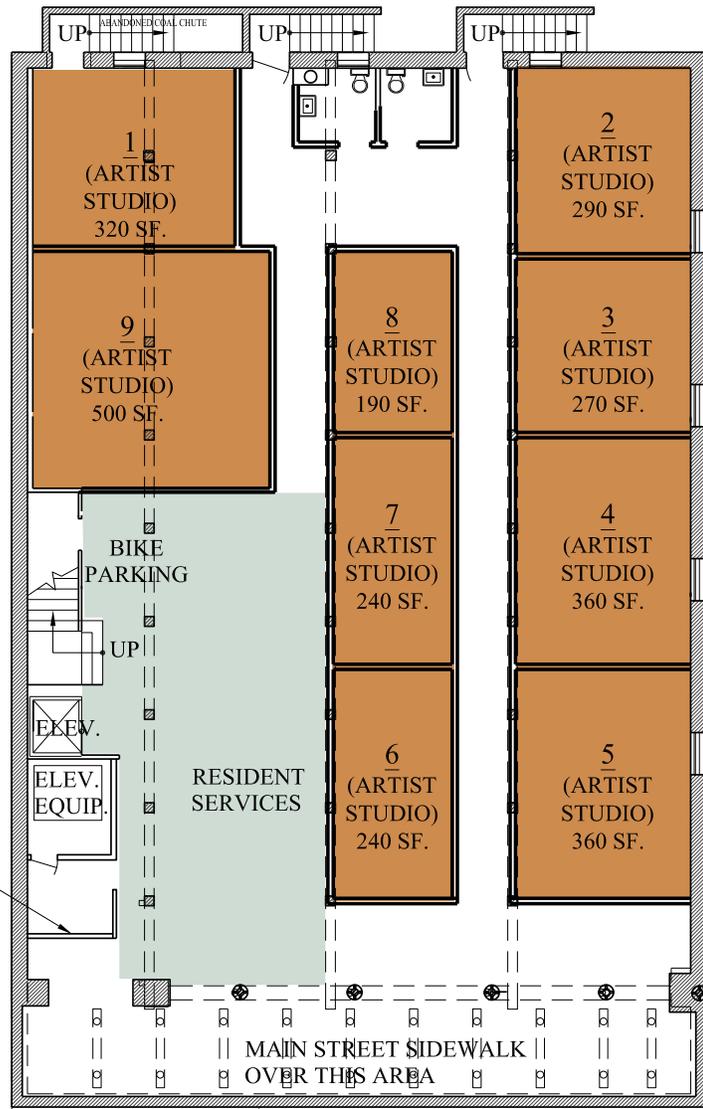
Proposed Basement Plan

Please see the floor plan on the next page for a possible approach to accomplishing activation of the basement level of the building by introducing nine artist studios.

MAKE PERMANENT WATERPROOF IMPROVEMENT OF MAIN STREET FOUNDATION

The high ceilings, ability for daylighting, and dry nature of the basement make it a perfect location to create artist studio spaces. A similar project has been completed in the basement of a turn-of-the-century building in Portland—the Falcon Art Community. There is a mix of musicians, sculptors, painters, and writers who rent space in this creative enclave.

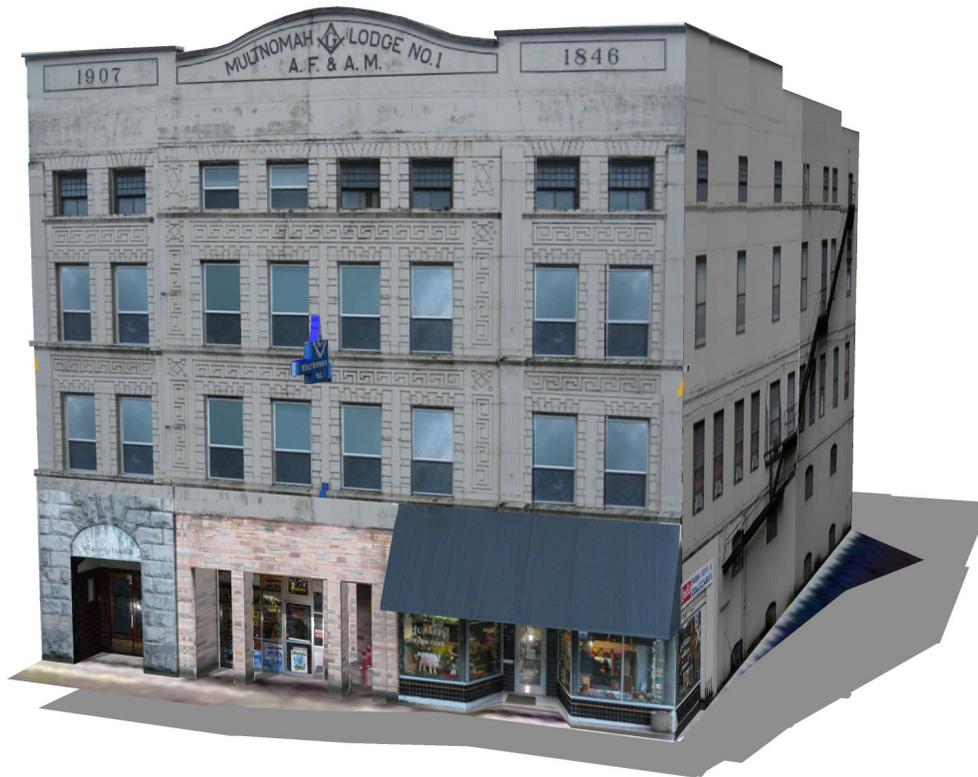
Existing Masonic Lodge Building

The following images show the building and a three-dimensional representation of the building program represented in the previous floor plans. Pay particular attention to the vaulted third /fourth-floor apartment that will be created by the lodge meeting space. The same color conventions are used as are found in the floor plans: yellow is retail, orange is office space, and green is residential.

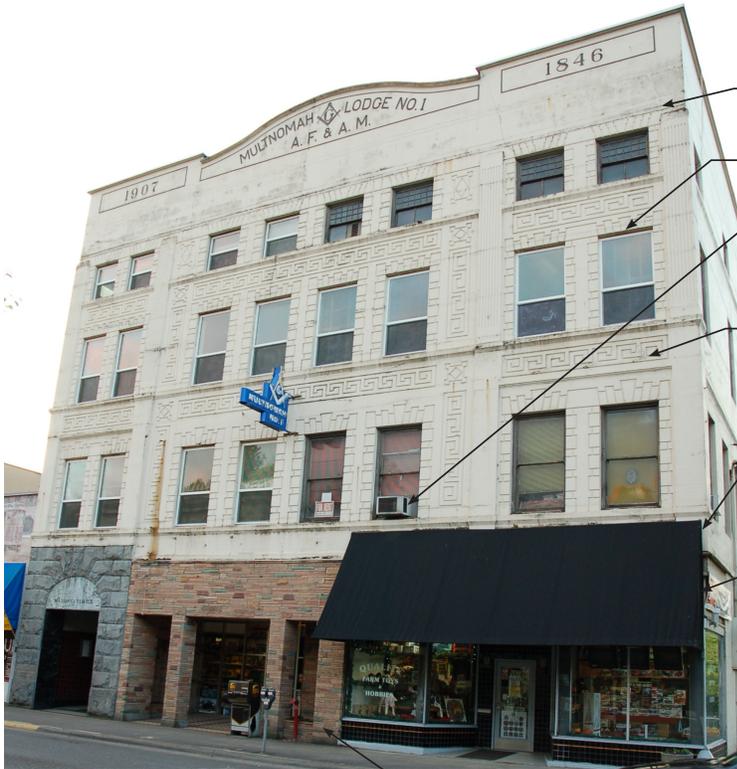
SW Facade-Masonic Building

Rebuild original cornice as seen in the historic photo.

Repair and repaint wood windows.

Clean and repaint facade with multicolor scheme that highlights architectural features.

Place new externally lit signage within sign band - wall-mounted with blade signage is preferred.

Lower top of fabric awning to expose full sign and above. Raise bottom of awning to align w/ horizontal mullion between display glass and transom or refer to historic photo for placement.

Remove 1960's stone veneer and replace storefront to match existing windows + tile base as seen on the corner.

The case study approach to facade improvement included the goal of preserving the building's ability to be listed on the National Register of Historic Places. Exterior renovation plans include restoring the original two storefronts and using color to highlight the scoring in the concrete. An explanation of the facade improvement plan is shown in the following pages, along with an example of a four-color paint scheme on an historic building.

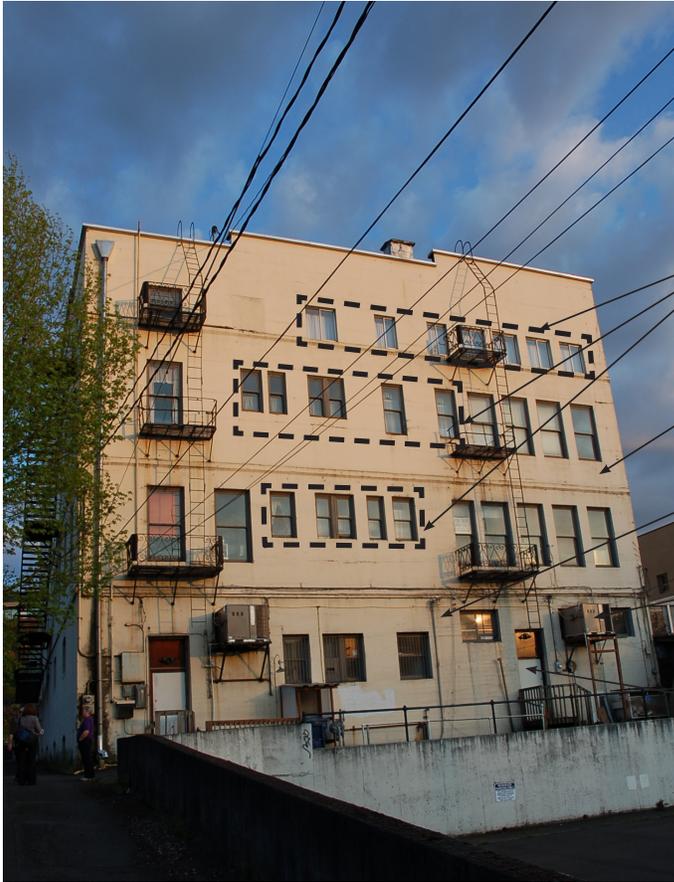
NE Facade - Masonic Building

Remove multiple (e) window units and cut in new windows for egress. Preferably new windows would match (e) large wood double hungs.

Clean and repaint facade

New lighting for potential basement tenants

Remove outdated HVAC units

New awning, lighting and signage for back of house office tenants

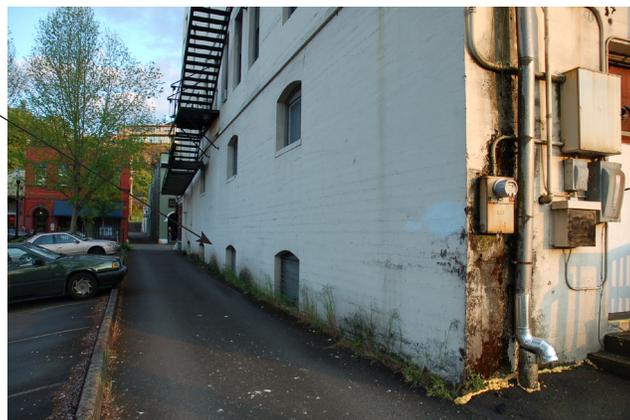
Additionally, the windows along the north face of the building that provide daylight to the basement should be restored. The artist studios that have access to a window will generate significantly more in rent.

Restore exterior facade windows to daylight the basement

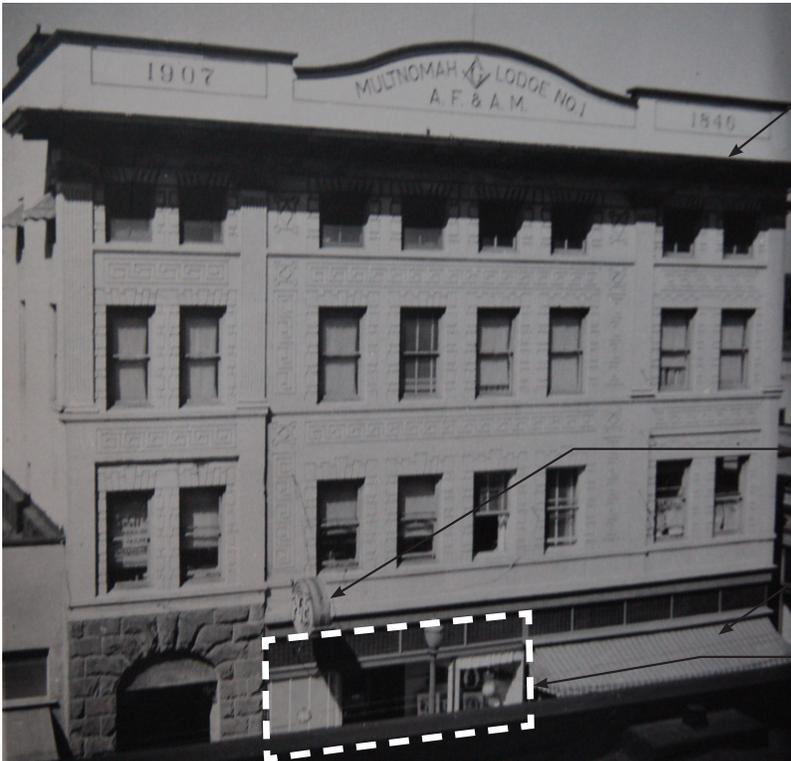
In the historic photo below, the cornice that ran atop the fourth floor windows was a very prominent feature of the building. The reintroduction of this cornice piece should be a goal when considering exterior facade improvement.

Restore original cornice element as per original construction documents.

New signage to be placed within sign band as shown in historic photo.

Fabric awning below prismatic glass transom.
